# **Tax Increment Financing Eligibility Study**

.....  
North Main Street /Chestnut Street  
Redevelopment Project Area  
.....

**City of Bloomington, Illinois**

**PGAV PLANNERS**

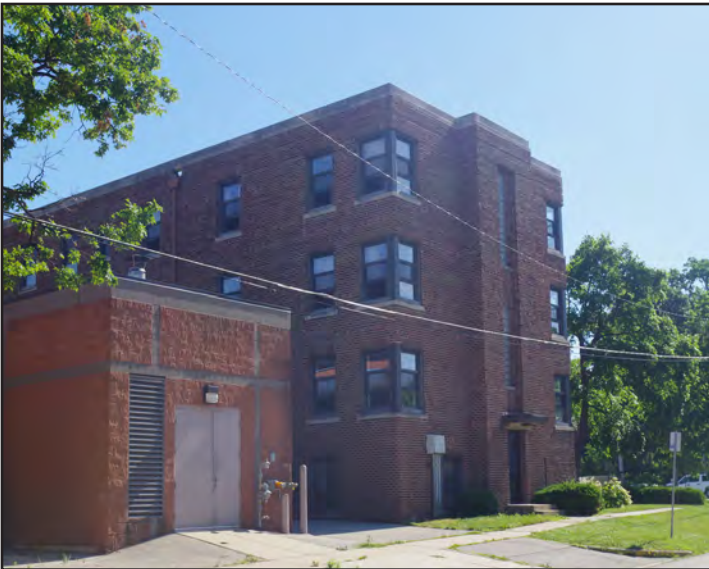
The former dormitory on 804 North East Street is vacant.

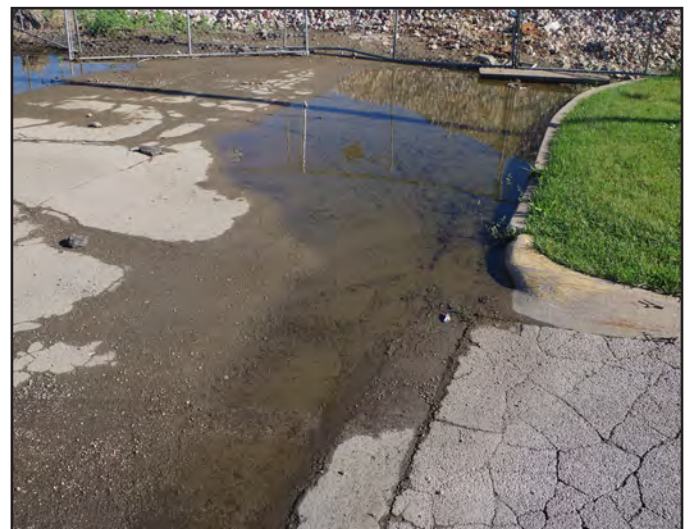
Standing water on the vacated North East Street right-of-way.

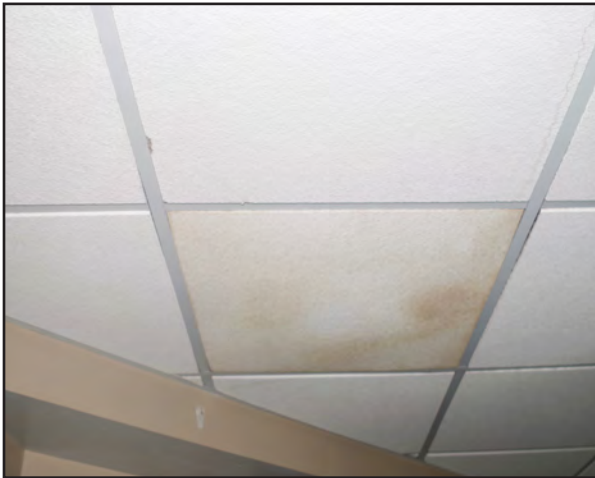
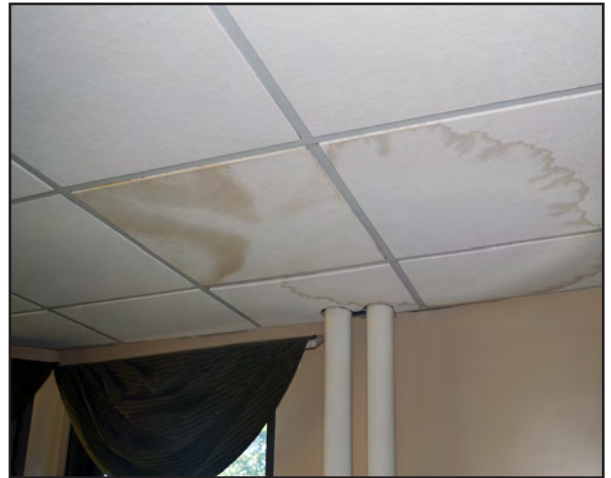
Left & Right:  
Water damaged  
ceiling tiles on the  
interior of the  
former dormitory.

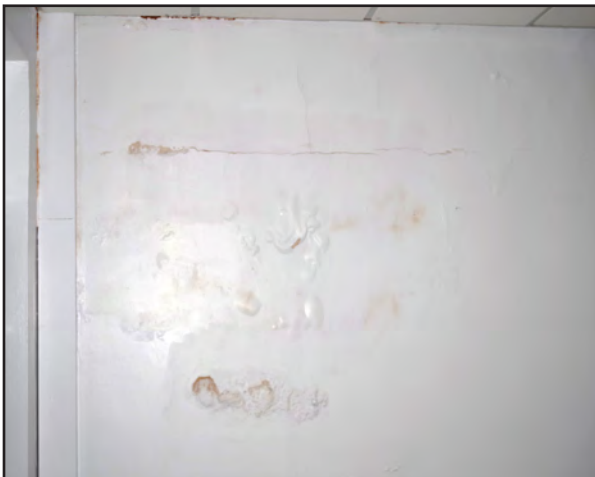
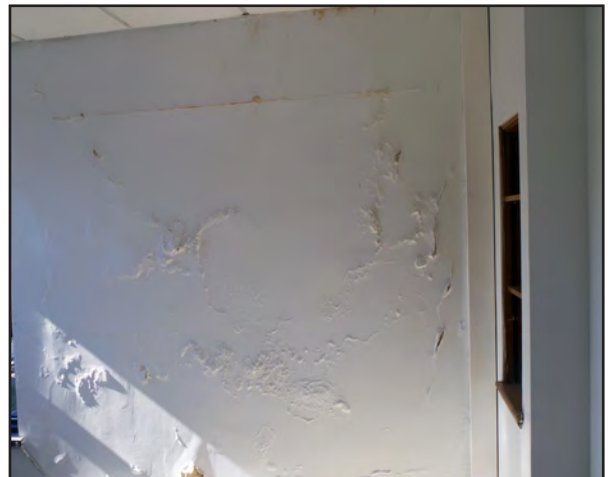
Left & Right:  
Water damage to  
the interior walls  
on the vacant  
dormitory.

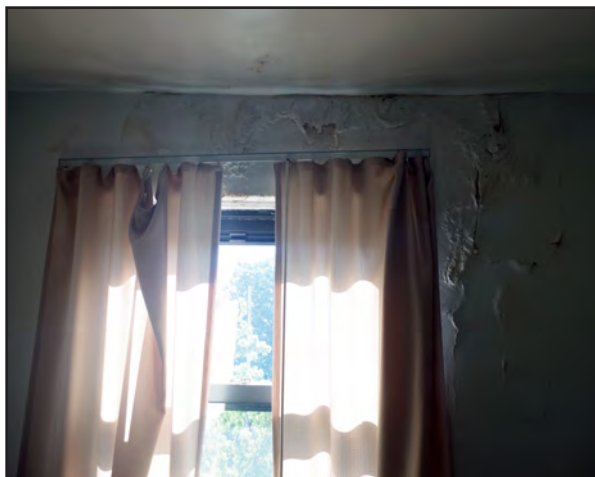
Left: Water  
damage around  
a window inside  
of the vacant  
dormitory

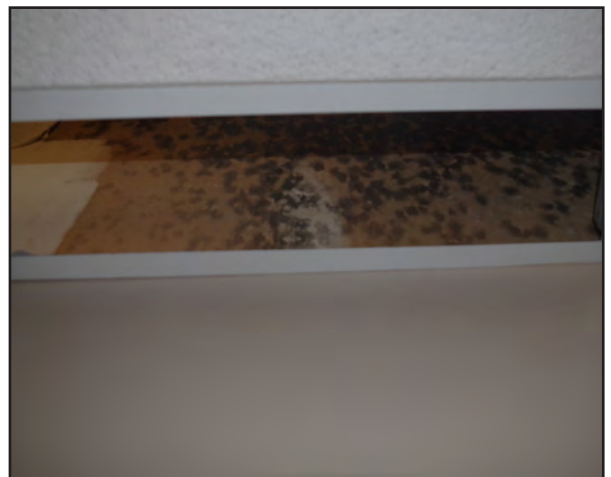
Right: Mold  
growing on an  
interior wall,  
above the drop  
down ceiling.

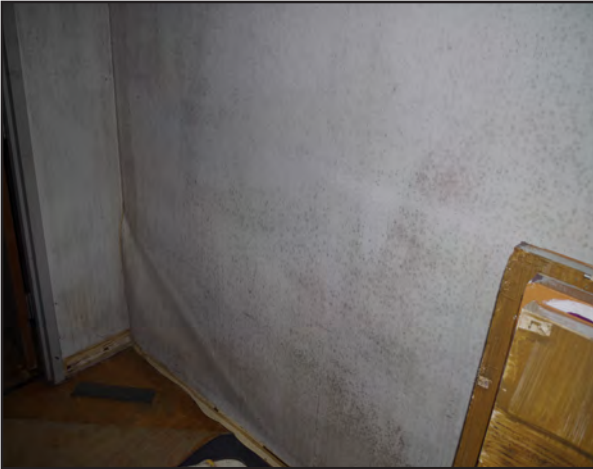
Left: Water damage and mold growth on an interior wall in the vacant hospital.

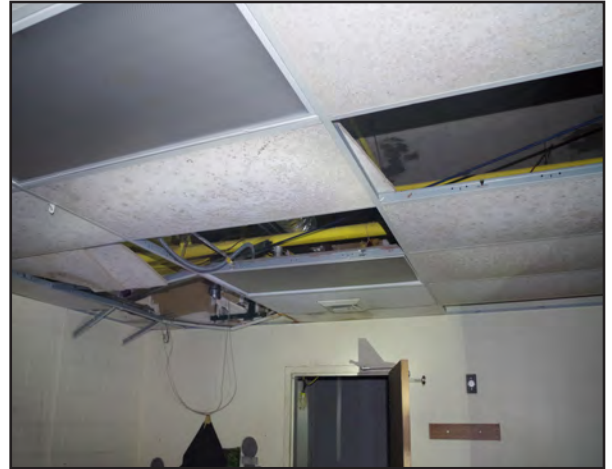
Right: Water damaged and collapsed ceiling tiles in the vacant hospital building.

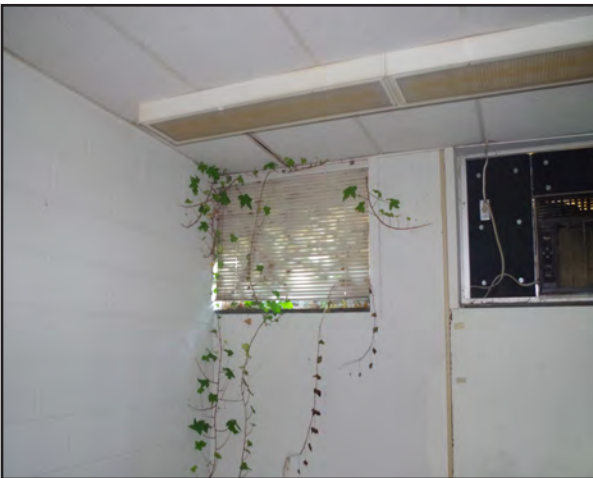
Left: Vegetation coming through a window of the former hospital building.

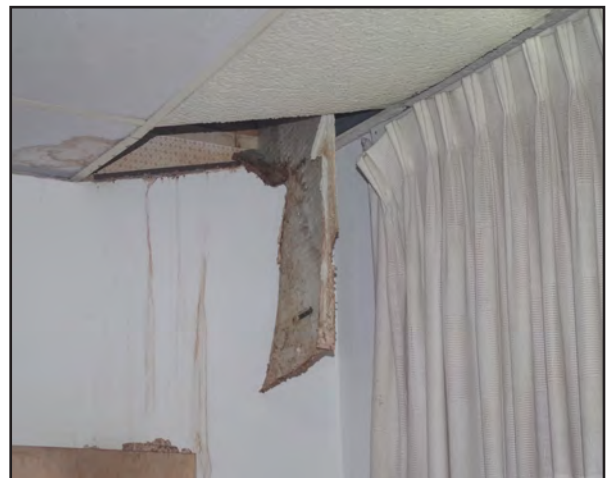
Right: Water damaged and collapsed ceiling tiles in the vacant hospital.

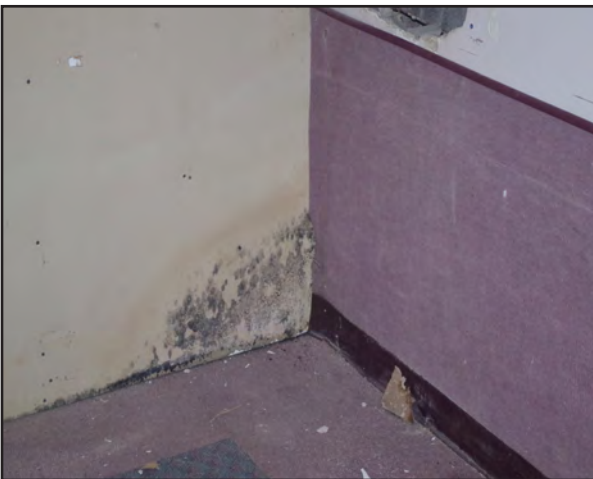
Left: Mold growth on an interior wall in the vacant hospital building.

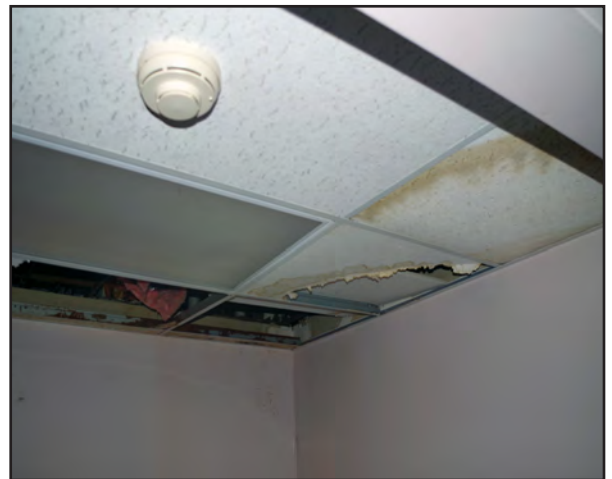
Right: Water damaged and collapsed ceiling tiles in the vacant hospital.

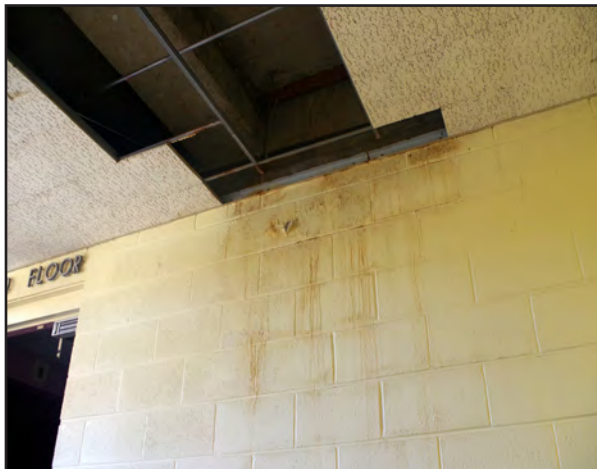
Left: Water running down the wall of the vacant hospital building has rusted the ceiling staining the wall.

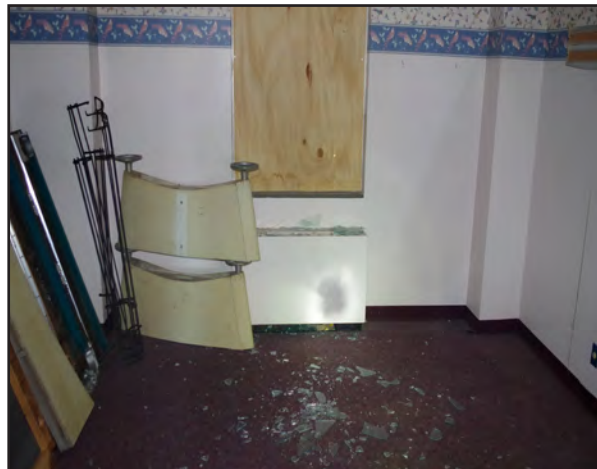
Right: A window appears to be broken by vandals to gain access to the inside of the building.

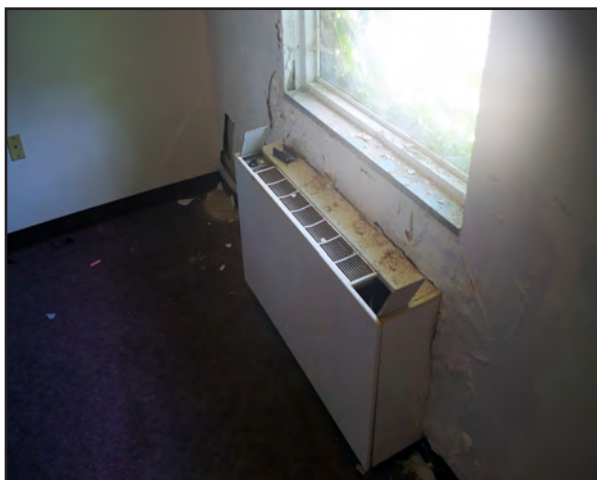
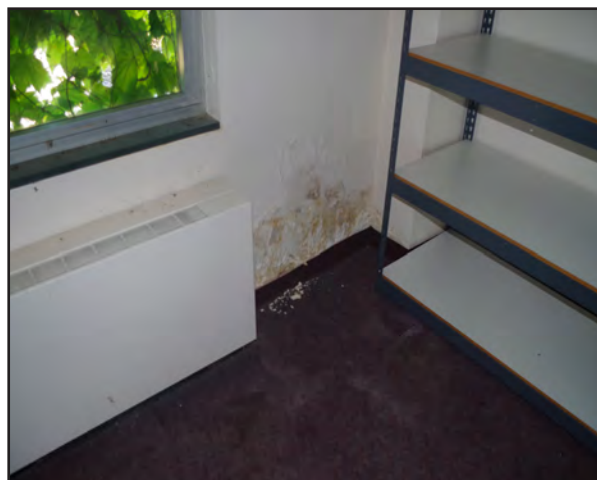
Left & Right: The plaster walls in the vacant hospital have water damage.

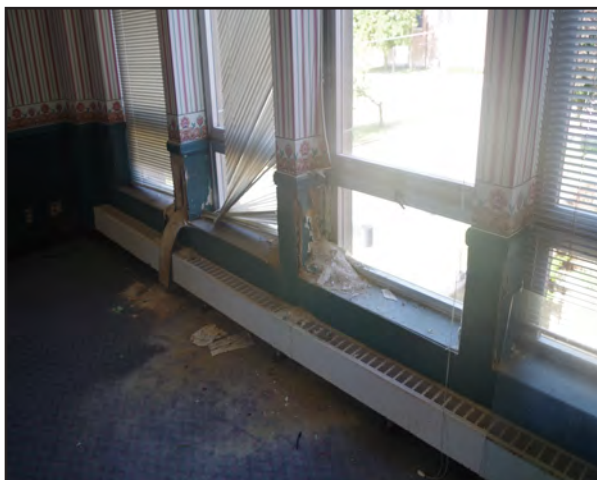
Left: The plaster covering the perimeter columns, of this interior room, is crumbling due to excessive water damage.

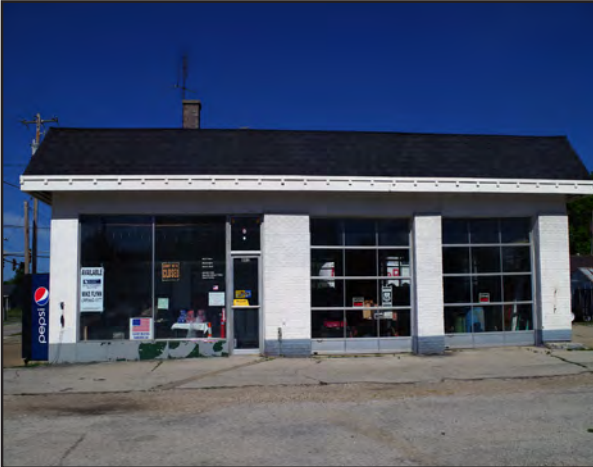
Left: The former Shell station located at 802 North Main Street is vacant.

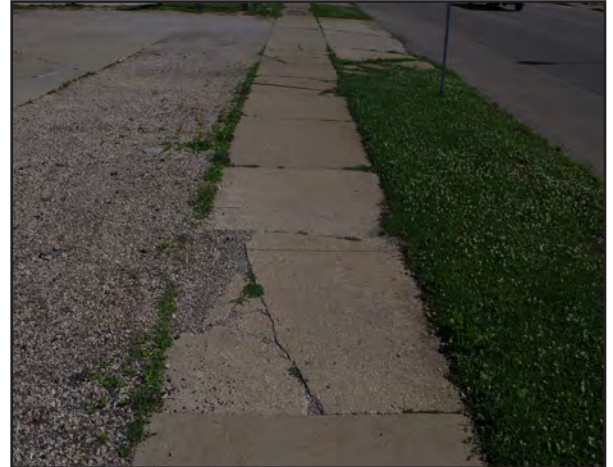
Right: The parking lot at 802 North Main Street covers the entire lot and abuts a deteriorated public sidewalk.

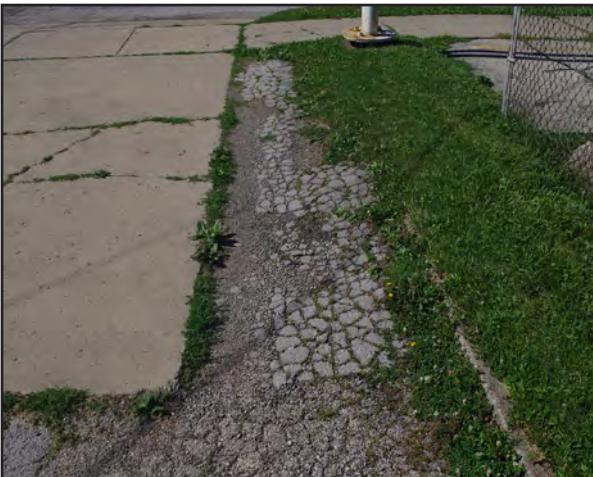
Left: The asphalt and concrete parking surface at 802 North Main Street is deteriorated.

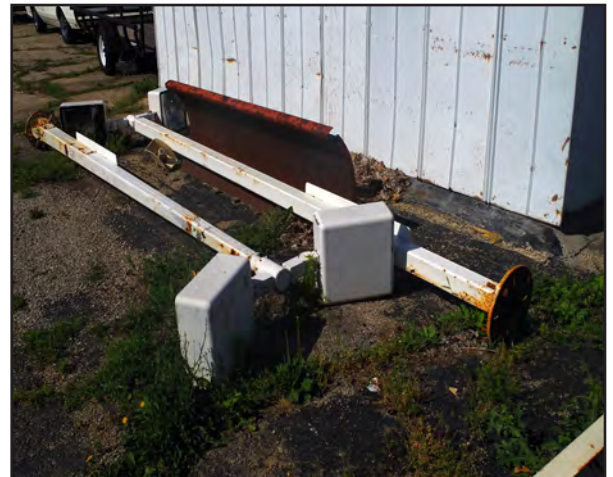
Right: The lighting standards for 802 North Main Street are rusted and lying on the ground.

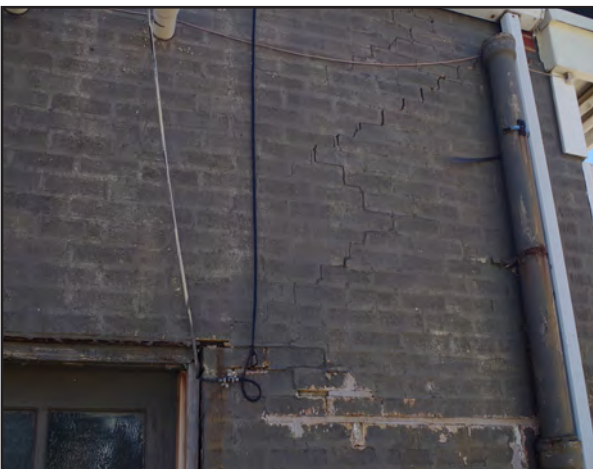
Left: Step cracking on the exterior walls of the former Shell building.

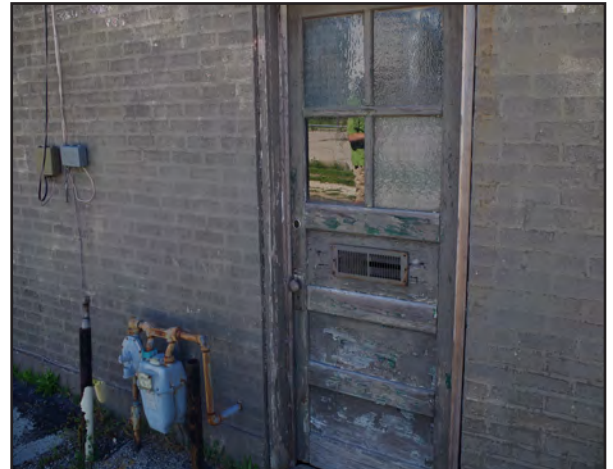
Right: The rear door of the former Shell is rotted and deteriorated.

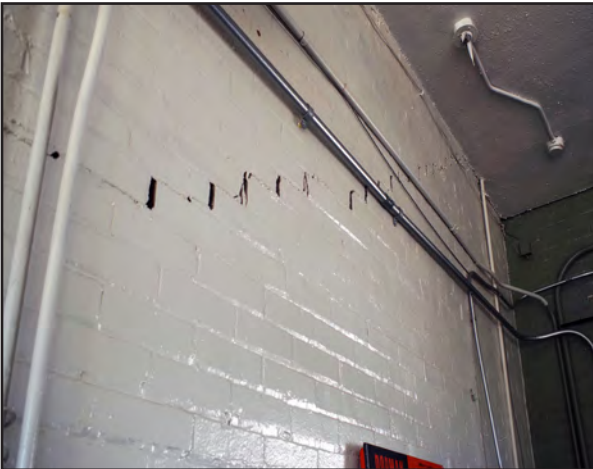
Left: Step cracking and shifting of the concrete blocks on the interior wall of the former Shell.

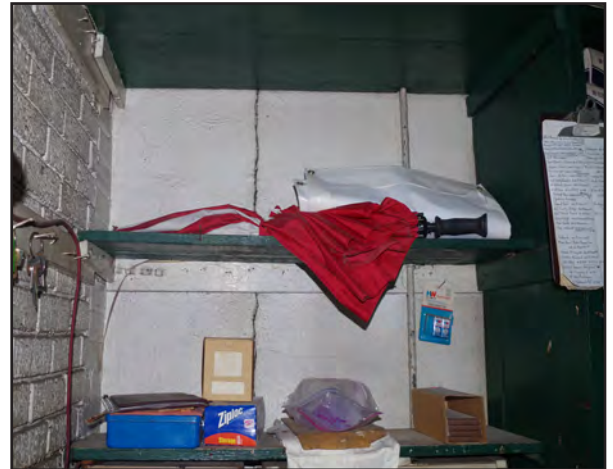
Right: A vertical crack in the masonry wall in the office of the former Shell.

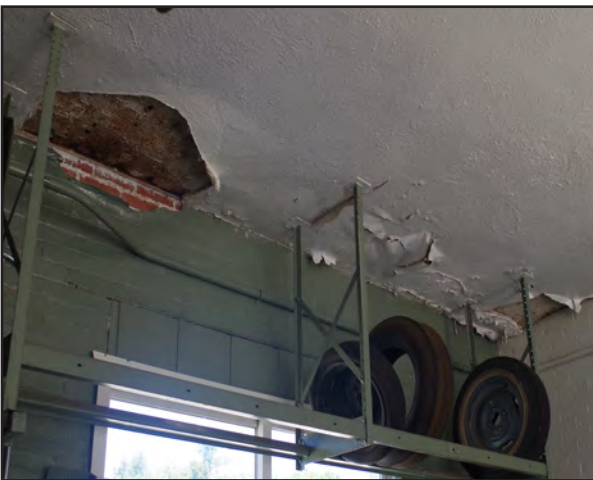
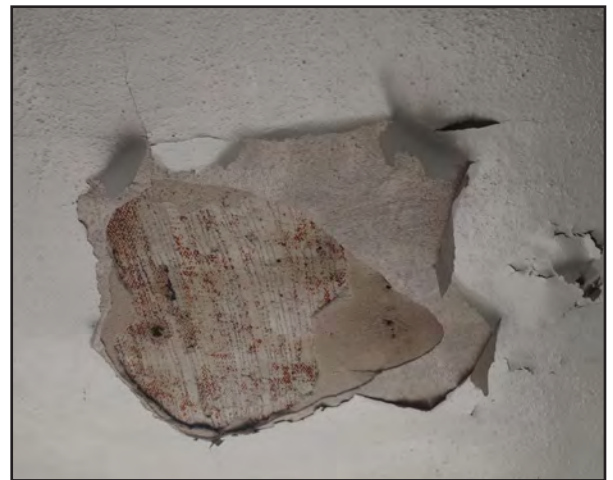
Left & Right: Water damage to the ceiling of the former Shell building.

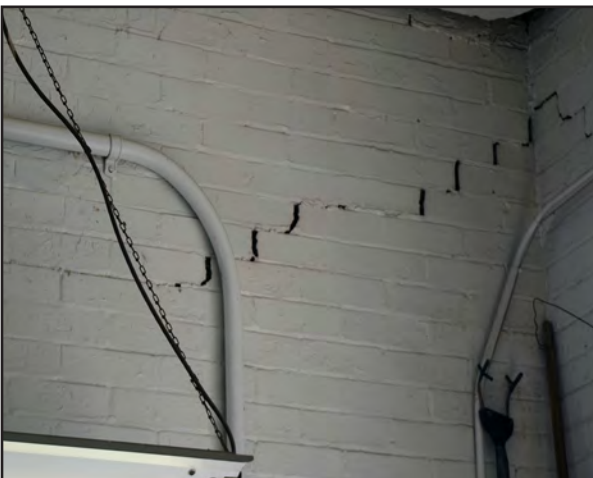
Left: Step cracking and shifting of the concrete blocks on the interior wall of the former Shell.

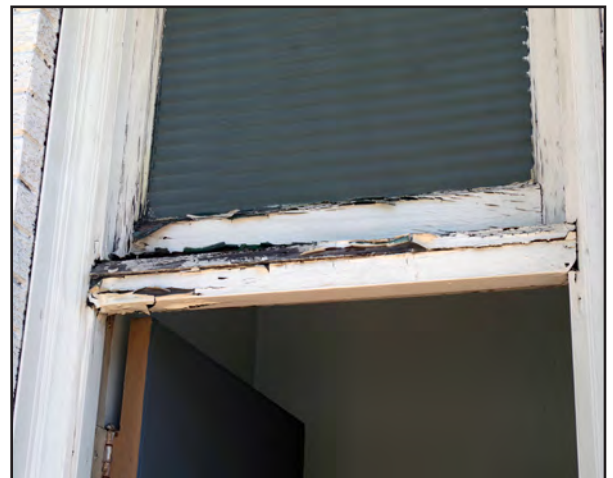
Right: The windows frames of the former Shell are rotted.

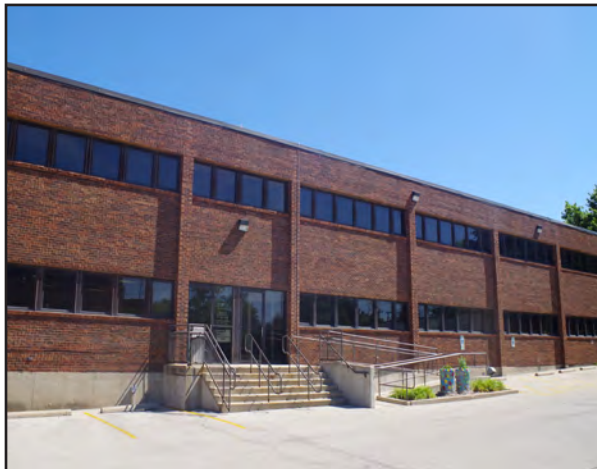
Left: The Bloomington Creativity Center is over 50% vacant.

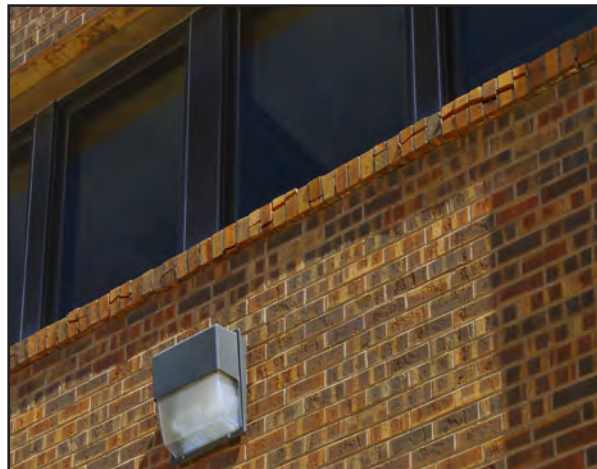
Right: Sheer cracking in the exterior brick sills of the Creativity Center.

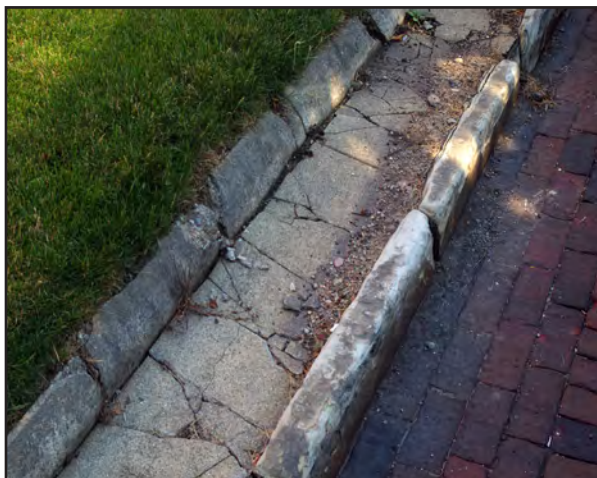
Left: A deteriorated drainage channel along North East Street.

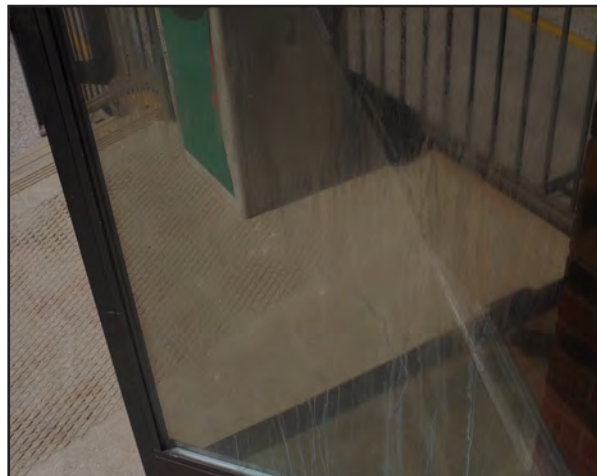
Right: Moisture inside of the glass door of the Creativity Center, indicating the seals have failed.

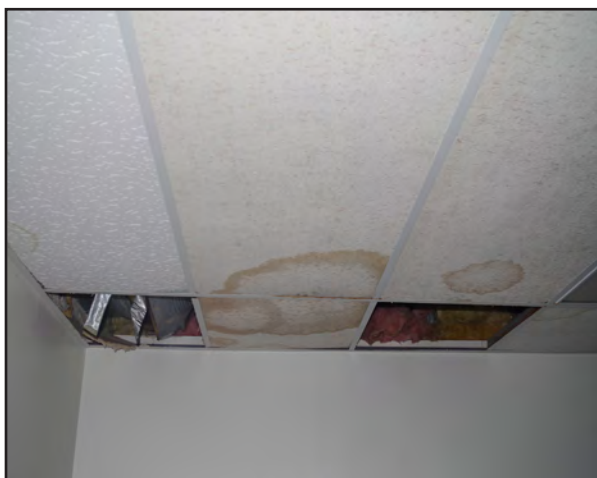
Left: Water damaged and collapsed ceiling tiles at the Creativity Center.

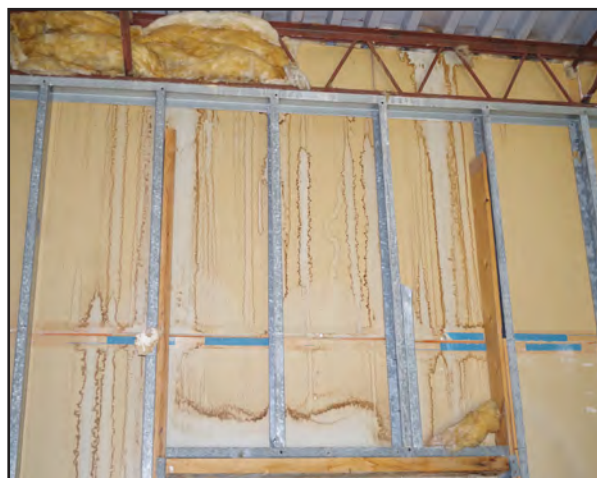
Right: Water stained drywall, due to a roof leak, in the Creativity Center.

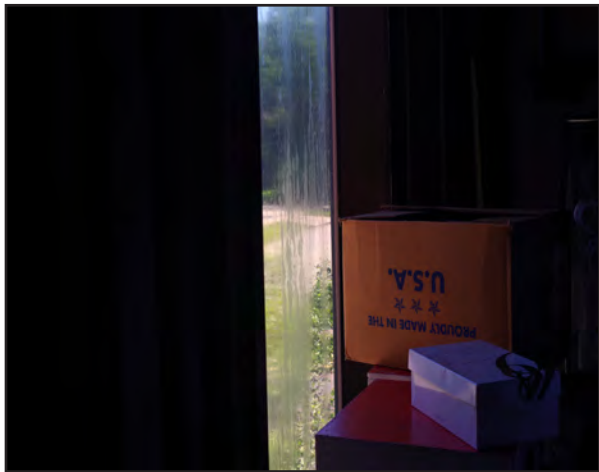
Left: Moisture in a window, due to failed seals, in the Creativity Center.

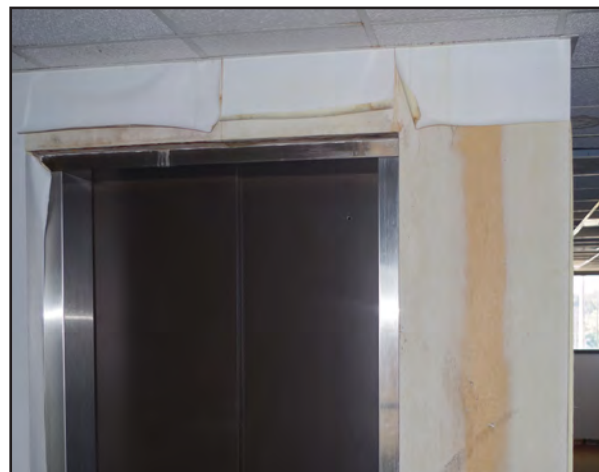
Right: Water damage around the elevator in the Creativity Center.

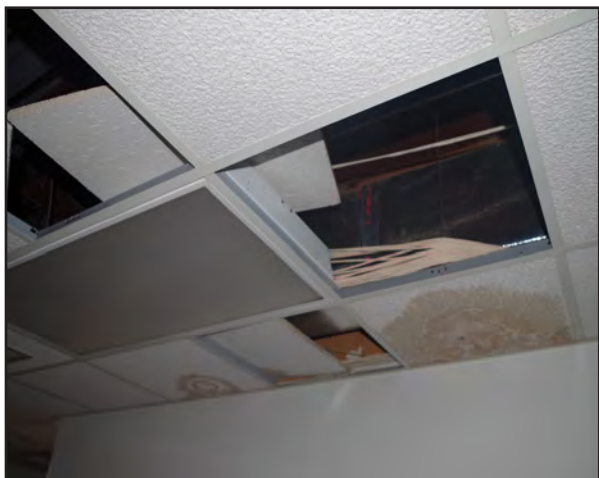
Left: Water damaged and collapsed ceiling tiles in the Creativity Center.

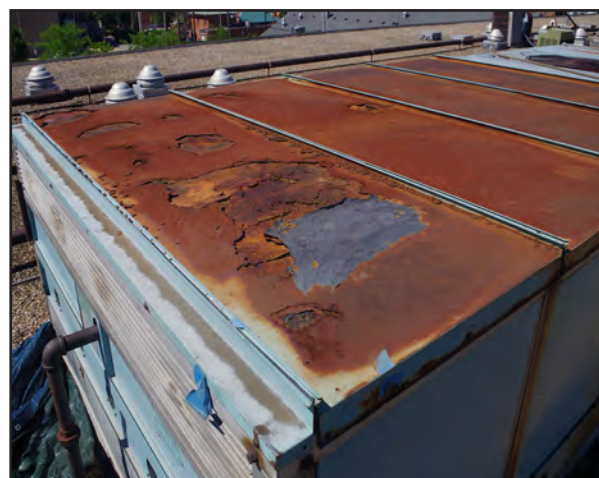
Right: The HVAC system on the Creativity Center is rusted and two of the three units are inoperable.

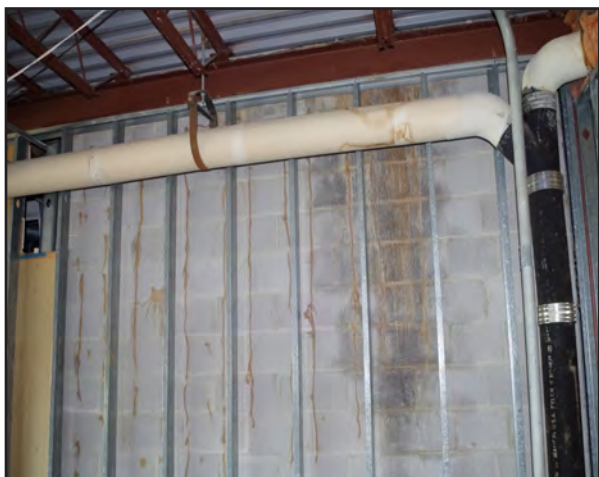
Left: Water running down the wall of the Creativity Center rusted the ceiling structure and stained the wall.

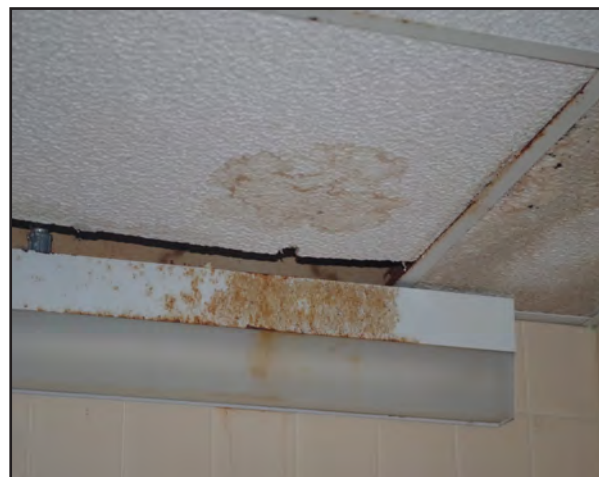
Right: Water damaged ceiling tiles inside of the Creativity Center.

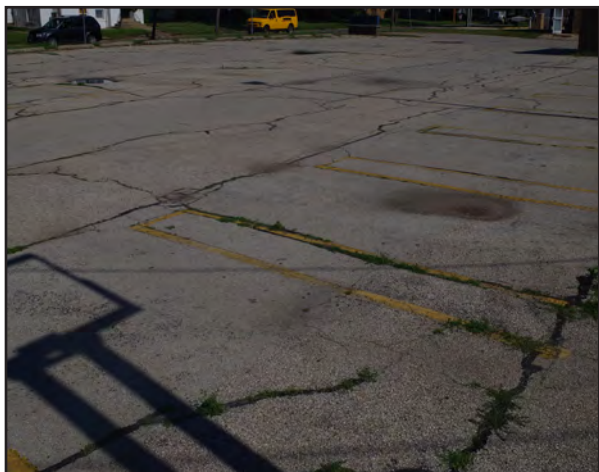
Left: Cracking in the asphalt parking lot located at 103 West Chestnut Street.

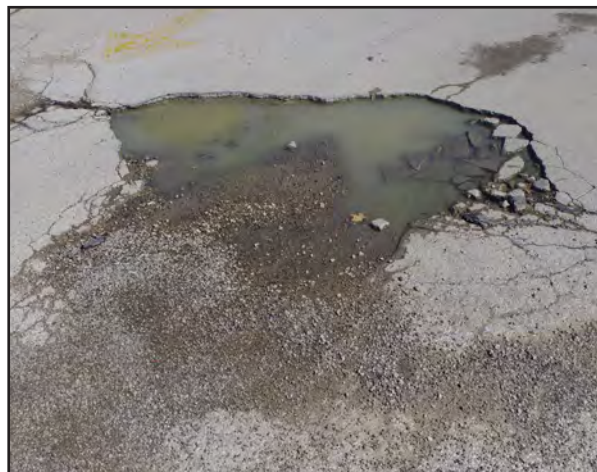
Right: A pothole, containing standing water, located at 103 West Chestnut Street.

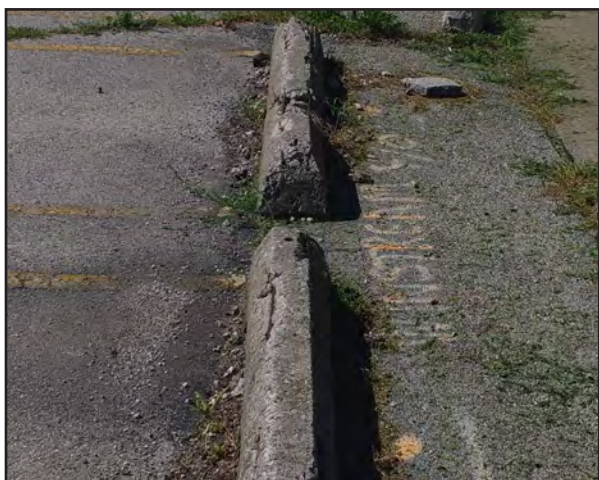
Left: The curb stops for 103 West Chestnut Street are deteriorated, exposing their steel reinforcing bars.

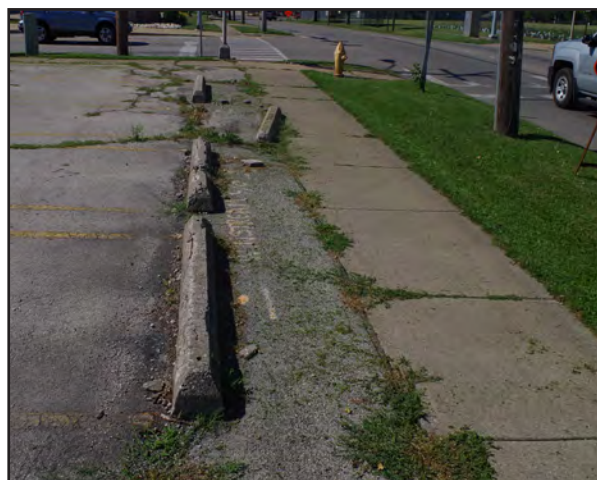
Right: A dislodged curb stop located at 103 West Chestnut Street.

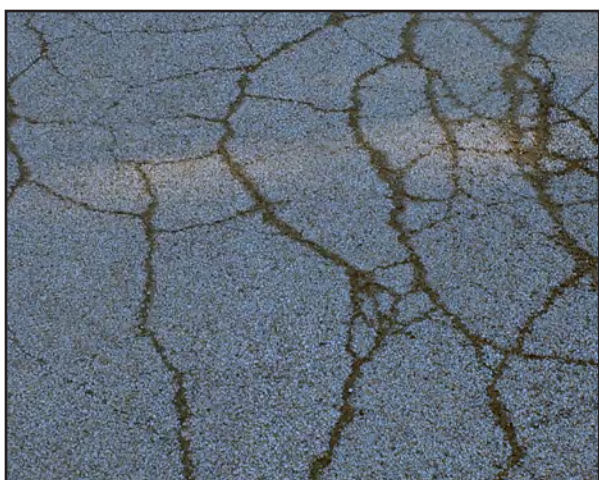
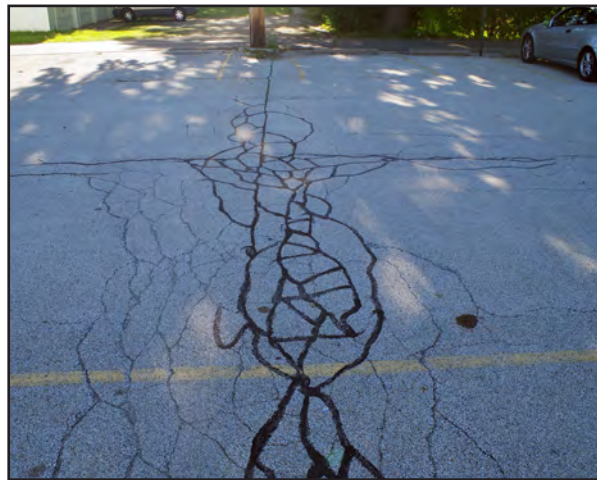
Left & Right: Cracking in the asphalt parking surface at 208 East Chestnut Street.

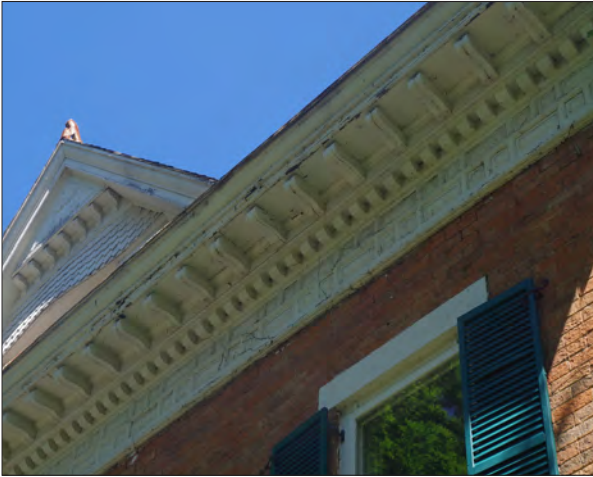
Left: The soffit and fascia on the Burr House are deteriorated.

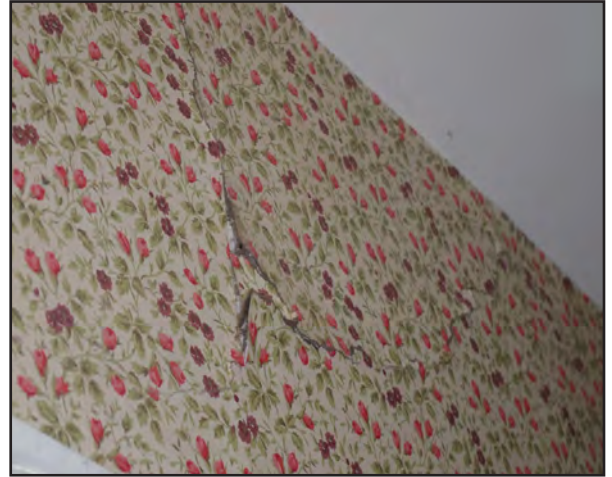
Right: Cracking on the interior plaster wall of the Burr House.

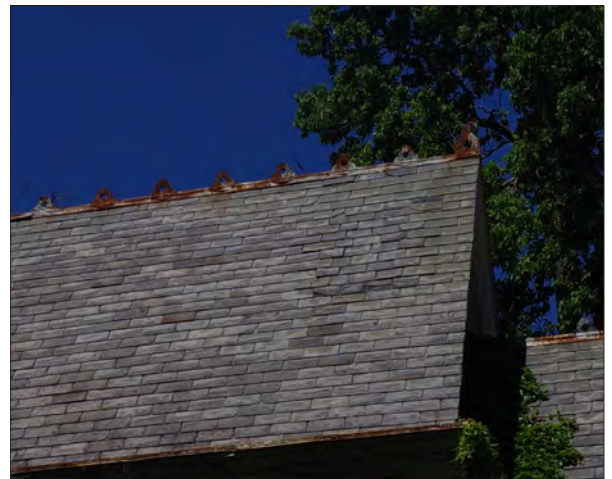
Right: The slate roof on the Burr House is deteriorated and the flashing is rusted.

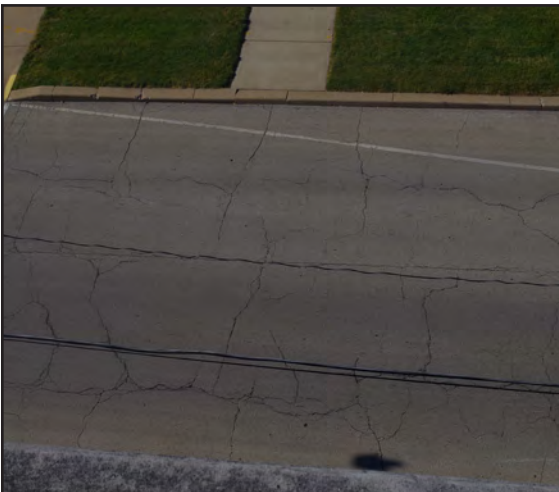
Left: The pavement on West Chestnut is cracked and deteriorated. (Between North Main and North East Streets)

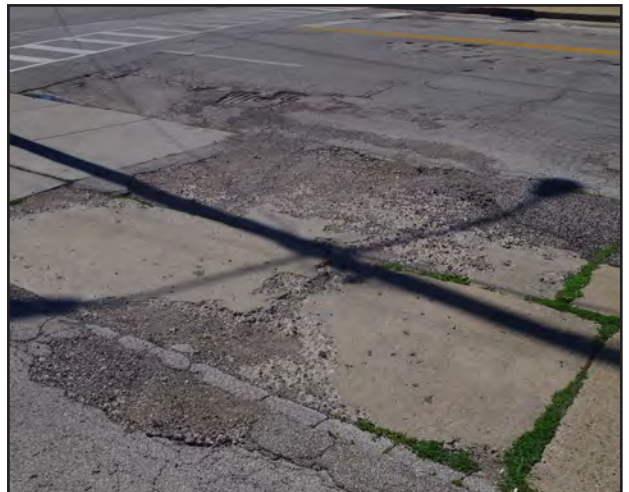
Right: The street pavement along West Chestnut, and the apron entering 802 North Main Street, are deteriorated.

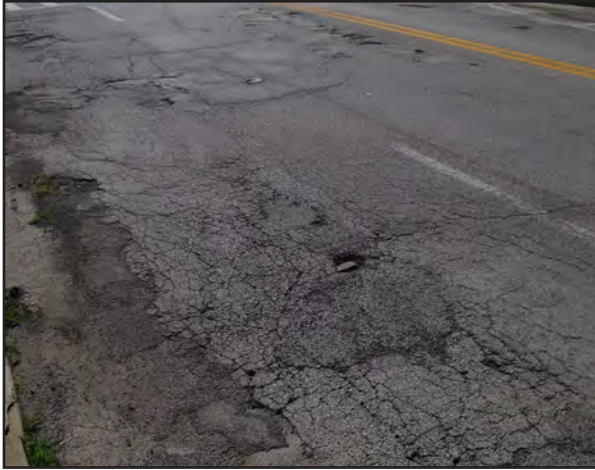
Left: Deteriorated street pavement along West Chestnut. (West of North Main Street)

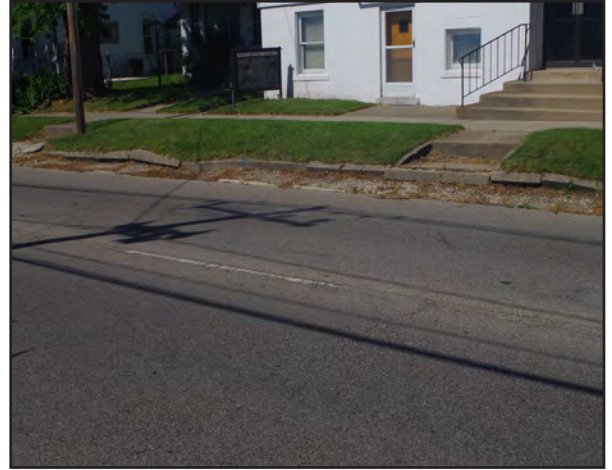
Right: The curbs along the west side of North Center Street are severely deteriorated.

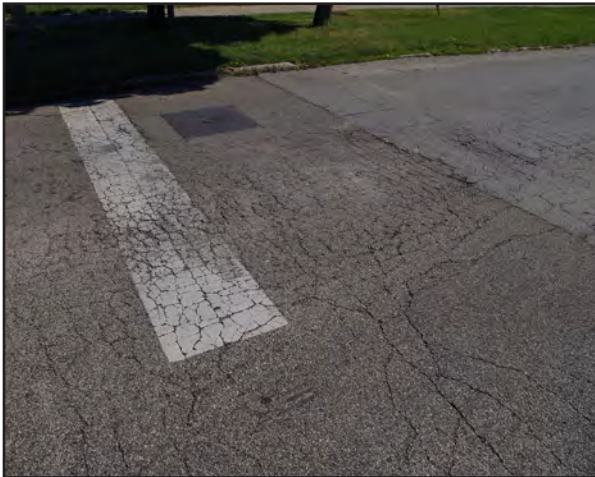
Left: The paving at the intersection of North Main Street and West Chestnut Streets has alligator cracking.

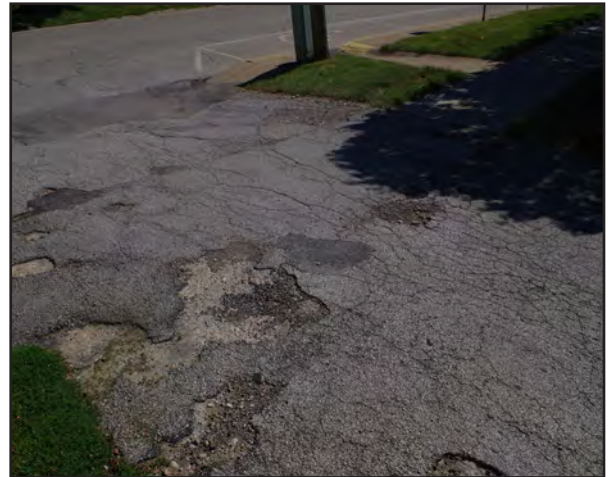
Right: The alley just west of 103 West Chestnut Street is deteriorated.

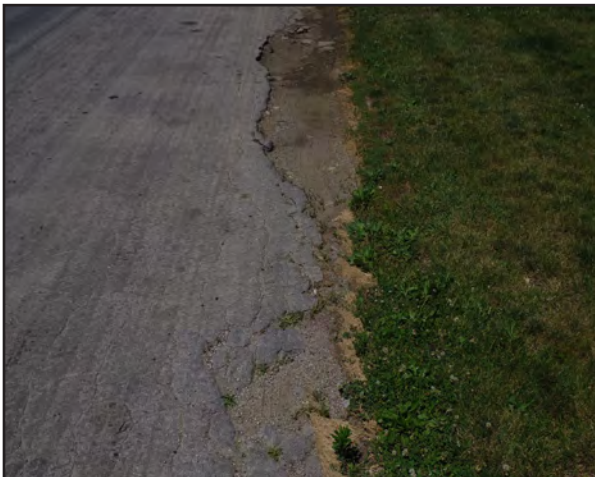
Left: The edge of the pavement along West Walnut Street is deteriorated. (Between North Main Street and North East Street)

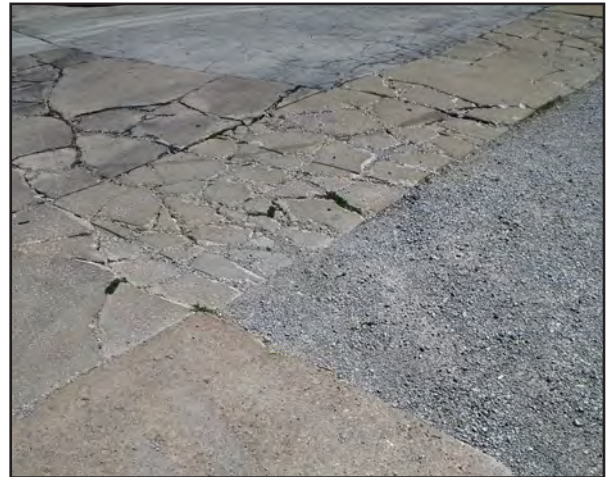
Right: The sidewalk along West Walnut Street is severely deteriorated. (Between North Main Street and North East Street)
