CITY COUNCIL QUESTIONS/COMMENTS AS OF JULY 8, 2013 AT 9:47 AM
JULY 8, 2013 CITY COUNCIL AGENDA
STAFF RESPONSES

RE: City of Bloomington Market Street Parking Structure Walk-Through
Condition Assessment
FGI Project No. 0070120.00

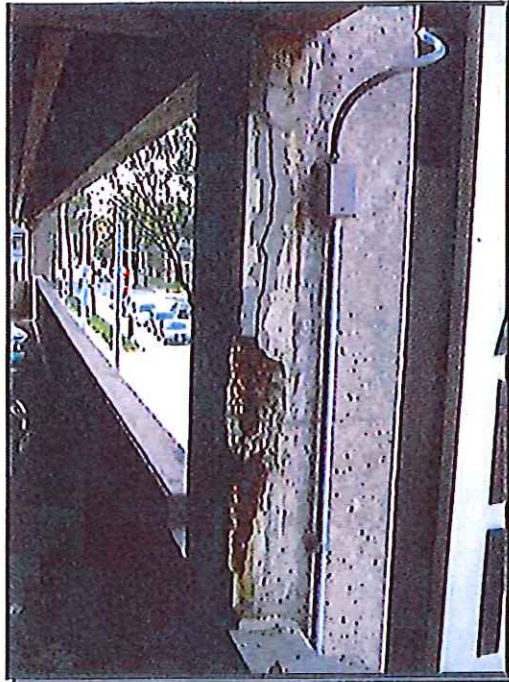
3. There are several locations where the exterior concrete columns have cracked and spalled. Some of these locations have been previously repaired, but show evidence of repair failure.

Recommendations: Remove the spalled concrete and/or failed previous repair from the column. Clean all rebar in the exposed areas and treat the steel with a corrosion inhibitor. Patch the area with a structural concrete repair material. Rout and seal all remaining cracks.

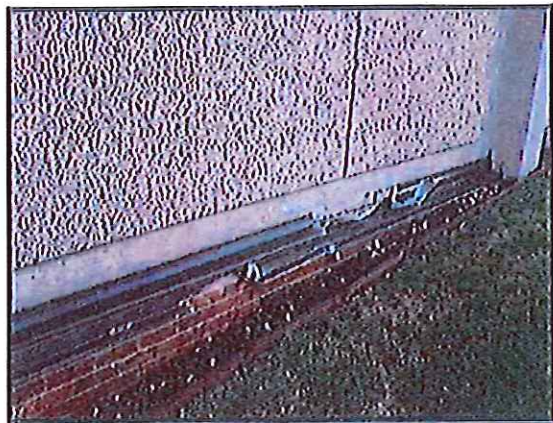
5. On the west face of the parking deck, between column lines F and G, the flashing at the base of the wall panel is damaged.

Recommendations: Remove and replace the flashing in this location.

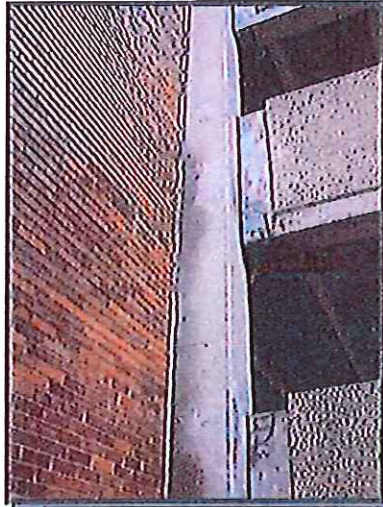
6. At the joints between the stair tower brick walls and the precast concrete, the joint sealant has failed.

Recommendations: Remove and replace the joint sealant between the stair tower walls and the precast concrete.

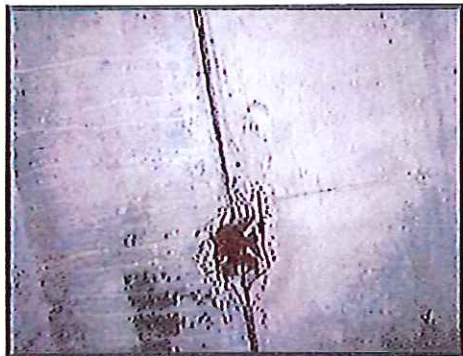
1. There are many locations throughout the parking deck where the concrete has spalled on the underside of the precast floor panels. These spalls occur along the joints, between precast floor panels and adjacent to the exterior edges of the deck. Some of these locations have been previously repaired, but show evidence repair failure. Most of the spalling appears to coincide with panel weld plate locations.

Recommendations: Remove the spalled concrete and/or failed previous repair. Clean all rebar and weld plates in the exposed areas and treat the steel with a corrosion inhibitor. Patch the area with a structural concrete repair material. In areas where weld plates have deteriorated to the point where they cannot be salvaged, install a galvanized angle on the bottom of the panels, spanning across the joint, similar to those in the previous repairs.

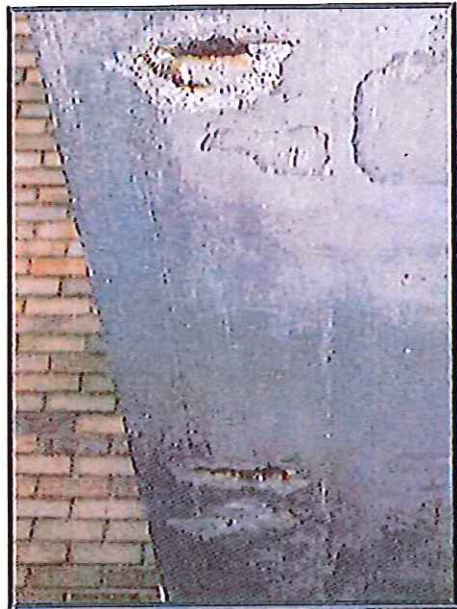
3. The bottom of the spandrel beams have begun to spall at several locations around the perimeter of the deck. In some locations, there appears to have been inadequate concrete cover on the rebar.

Recommendations: Remove the spalled concrete. Clean all rebar in the exposed areas and treat the steel with a corrosion inhibitor. Patch the area with a structural concrete repair material.

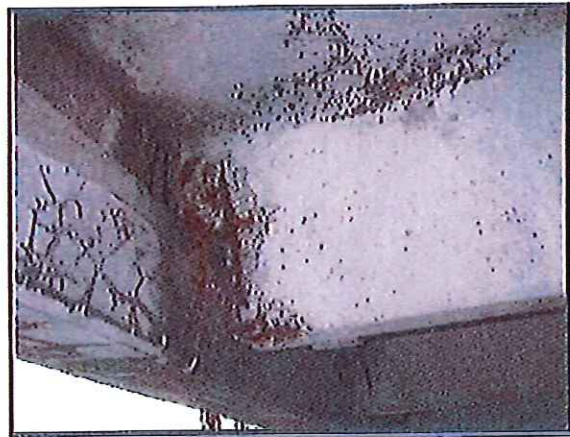
8. There are several locations throughout the deck where the concrete stems of the precast double tees that are bearing along the exterior edge of the deck have spalled and delaminated.

Recommendations: Remove the spalled concrete. Clean all rebar in the exposed areas and treat the steel with a corrosion inhibitor. Patch the area with a structural concrete repair material. Panels may require shoring during construction in locations where a significant amount of the concrete at the tee bearing must be removed to perform the repair.

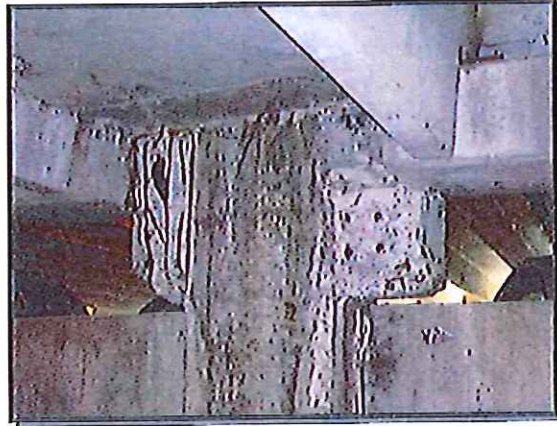
9. Column H2 has concrete haunches below the typical beam to column connection location. The concrete on the haunches has spalled and the rusted rebar, steel studs, and plates are visible. It appears that the original connection plates on the column were fabricated too low and the column was retrofitted with plates in the correct location. In this scenario the concrete haunches act as cover for the retrofitted steel connection.

Recommendations: The assumption that the concrete on the haunch is only a cover for the steel connection within cannot be confirmed without documentation from the original construction or observing the configuration of the steel connection after the concrete has been removed; therefore, shoring the beams connected to the columns prior to removing the spalled concrete from the haunches is recommended. A qualified Structural Engineer should observe the configuration of the steel within the haunch prior to proceeding. Clean

the rust from the rebar, studs and connection plates and replace the reinforcing as required by the Structural Engineer. Treat the steel with a corrosion inhibitor and patch the haunch with a structural repair mortar.

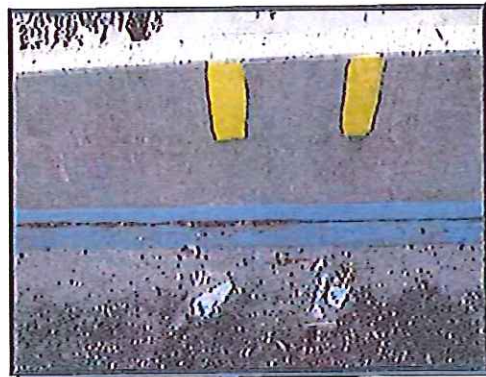
1. The joint between the south/middle spandrel and the floor panel has opened to a distance greater than the sealant could handle. The movement in this joint is possibly due to torsion in the long spandrel beam. It appears that adjacent spandrel beams have steel angles attaching the beam to the parallel floor panels, but the middle does not have these angles

Recommendations: The movement in the spandrel panels does not cause structural concern, but the joint must have a seal that allows movement while preventing water intrusion. We recommend installing an expansion joint between the middle spandrel beam and the parallel floor panel.

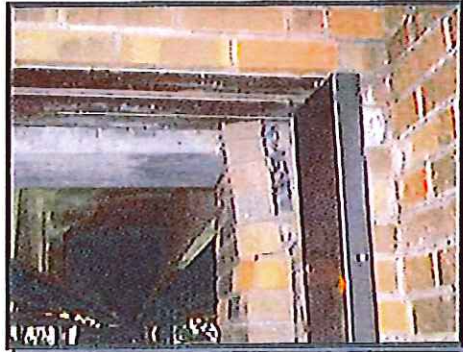
1. The brick veneer at the doorways leading into the stairwells has cracked at the corners below the door lintel. The brick in these areas is mortared tight to the bottom of the precast concrete structure. As the structure deflects due to live loads, it is pushing on the veneer.

Recommendations: Rebuild the cracked areas. Remove and rebuild the top course of brick adjacent to the precast concrete. Stop the top of the brick a minimum of 1/2" from the bottom of the precast concrete structure. Fill the joint with flexible sealant in lieu of mortar.

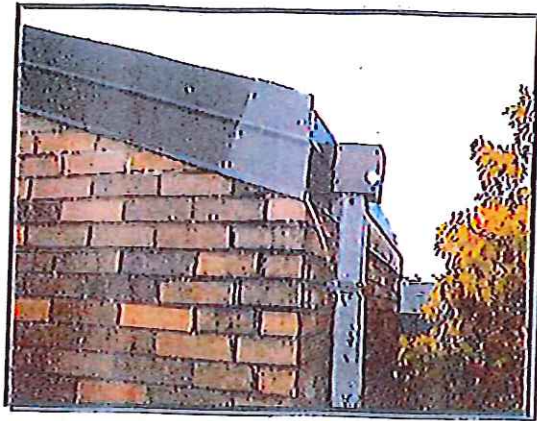
6. While it is raining, water runs down the exterior corner of the stairwell wall at the Fourth Level on both the Northeast and Southwest stairwells. This water is penetrating the brick walls and is visible from the inside of the stairwell. The mortar on the exterior face of the wall in these areas is cracked or missing in some locations. The water appears to be coming from behind the metal coping at the roof of the stairwells. It could not be determined during the walk-through, how the water is getting behind the coping.

Recommendations: Determine the source of the water leakage and make the necessary repairs. Then tuckpoint the brick.
