Tax Increment Financing Redevelopment Plan

.....
Downtown East Washington Street
Redevelopment Project Area
.....

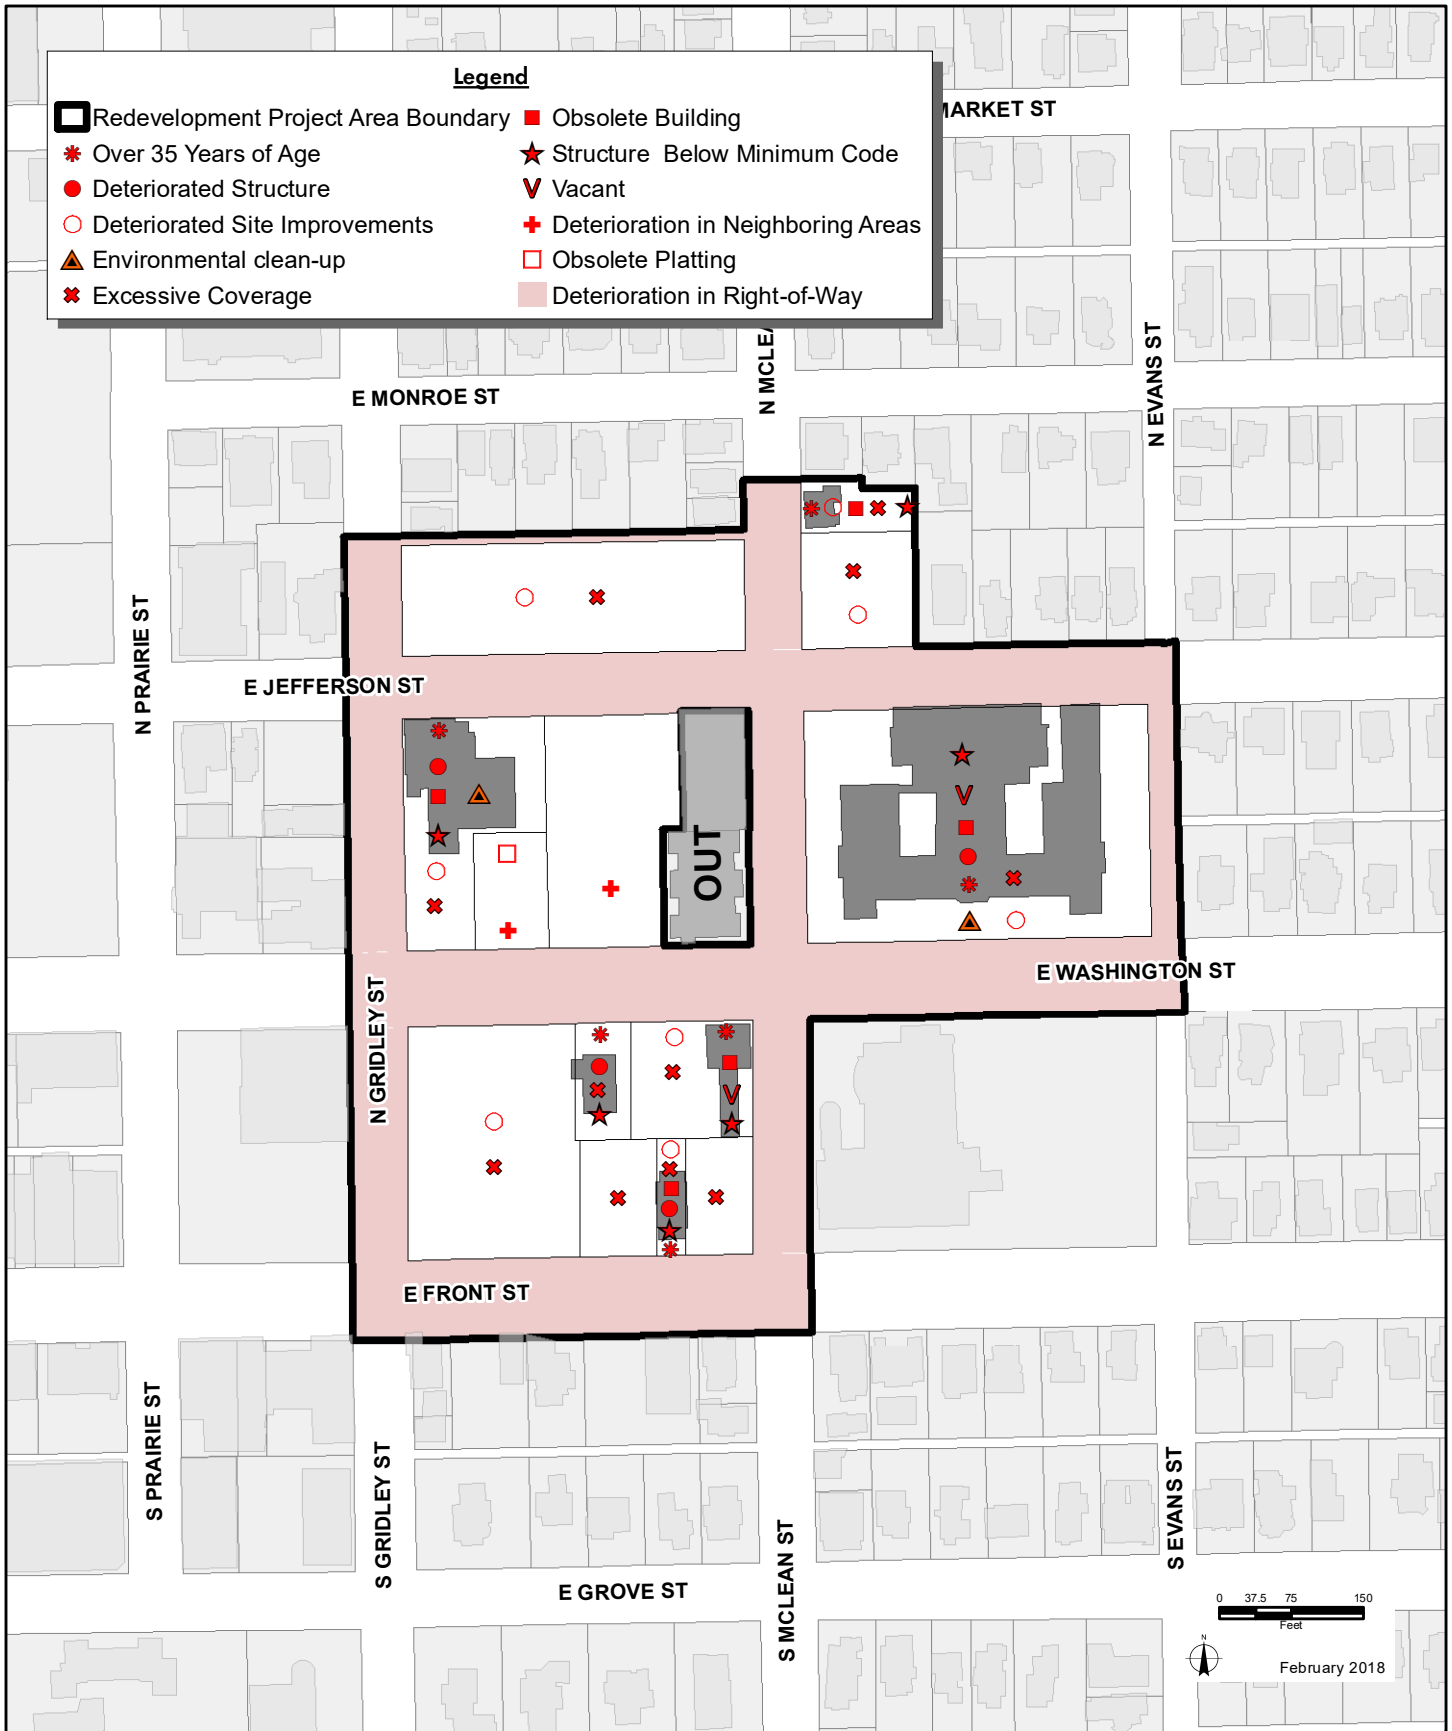
Exhibit D - Existing Conditions Map

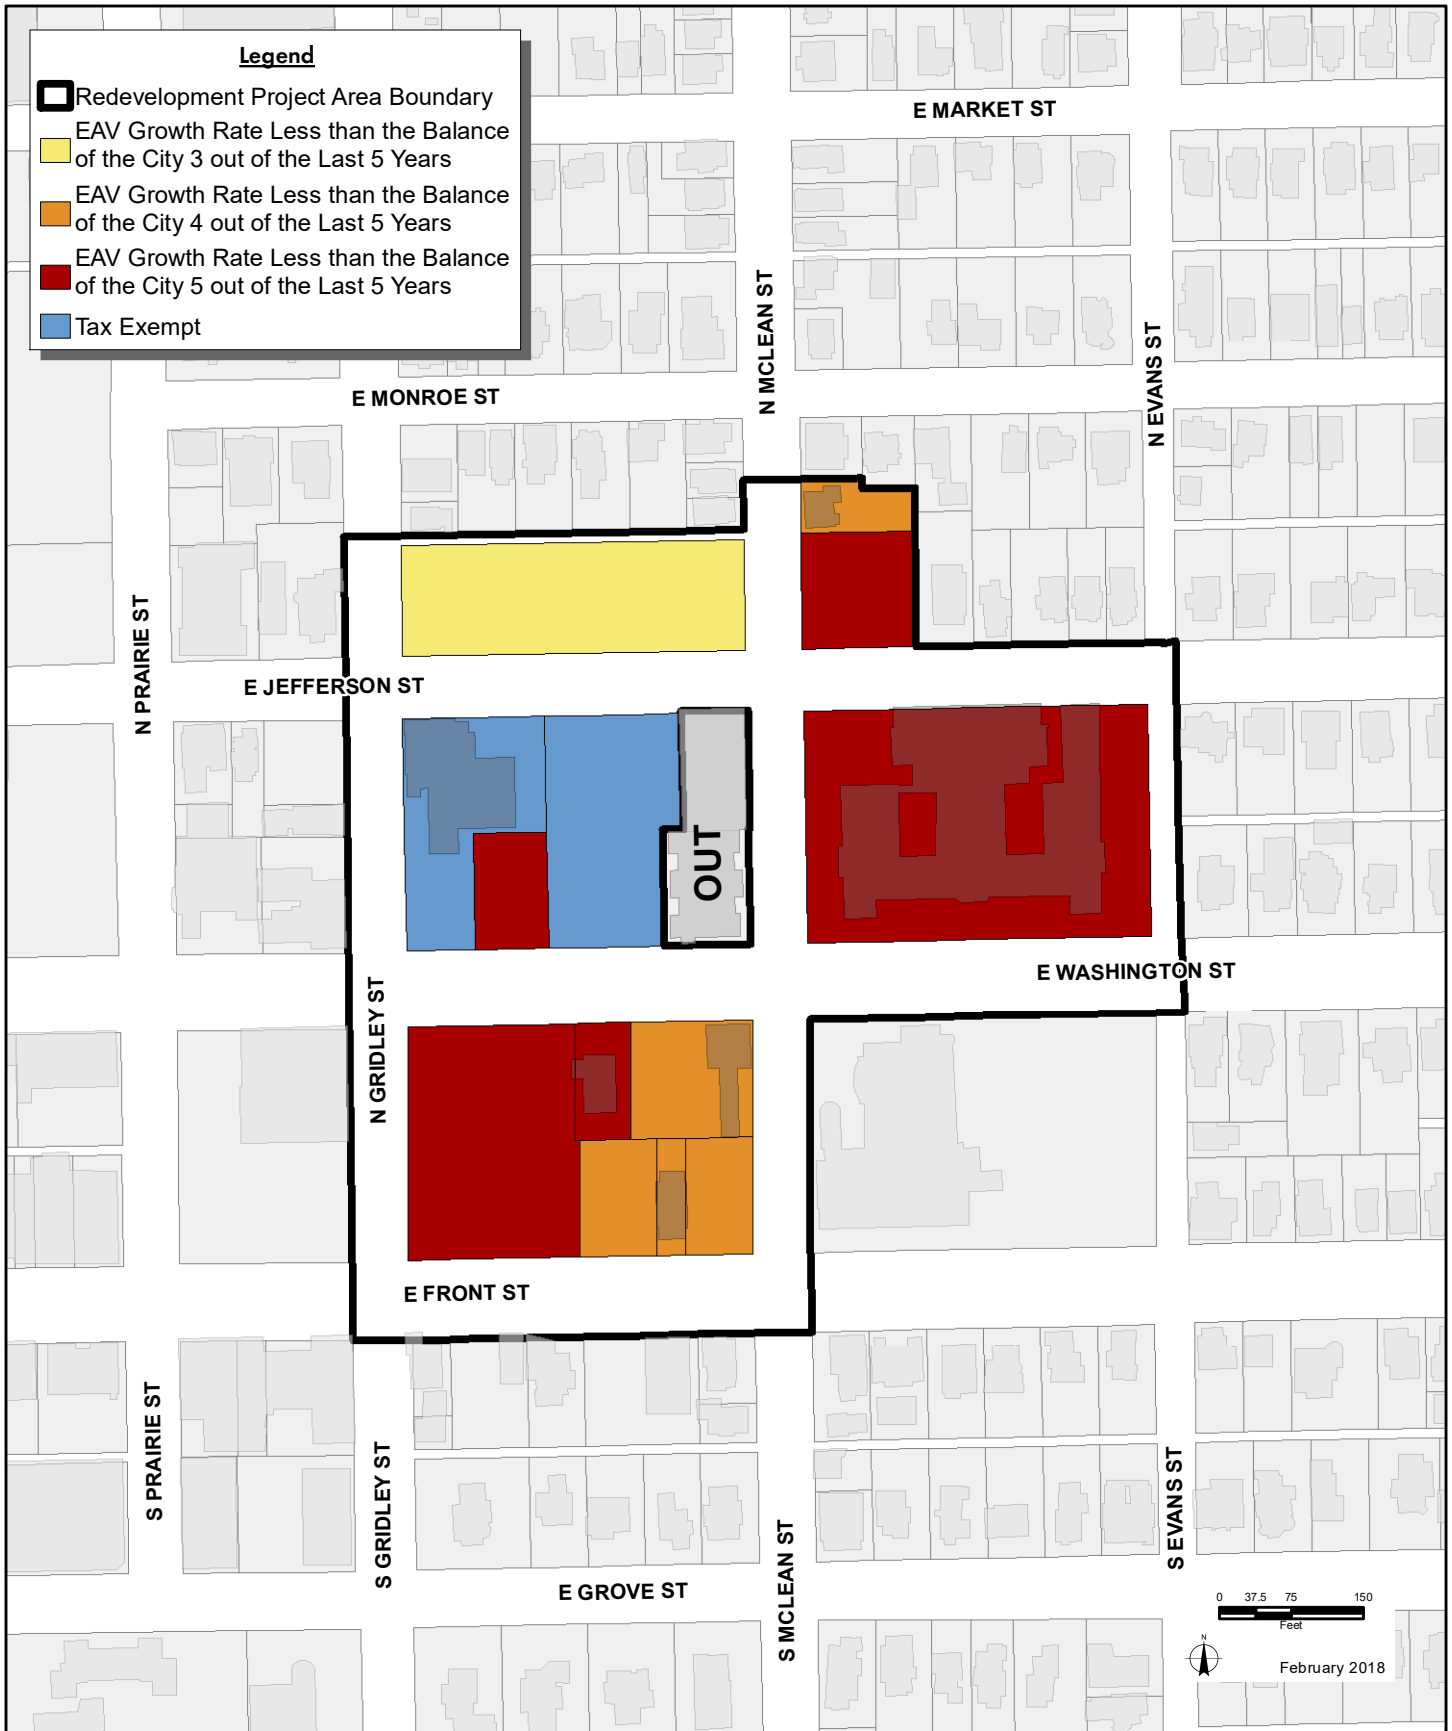
Exhibit F - Annual EAV Change by Parcel (2011-2016)

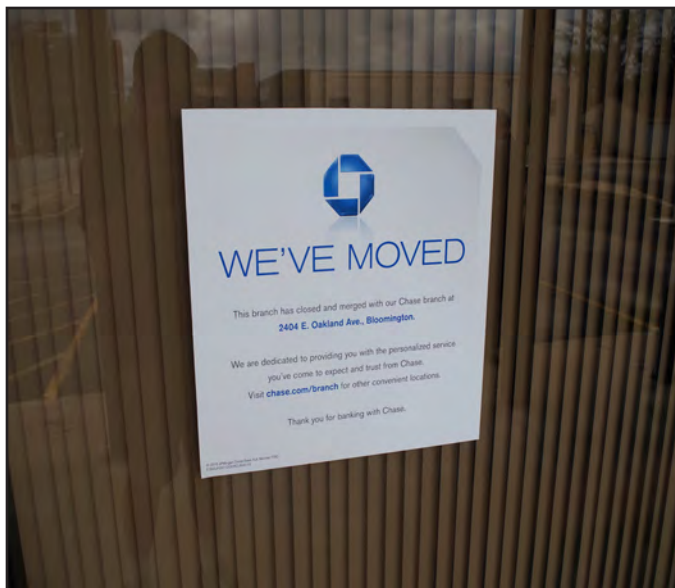
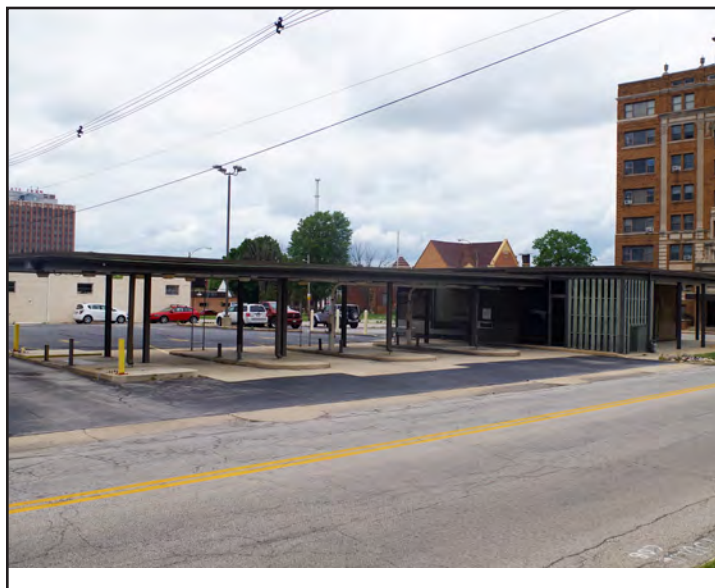
The former bank building is currently unoccupied.

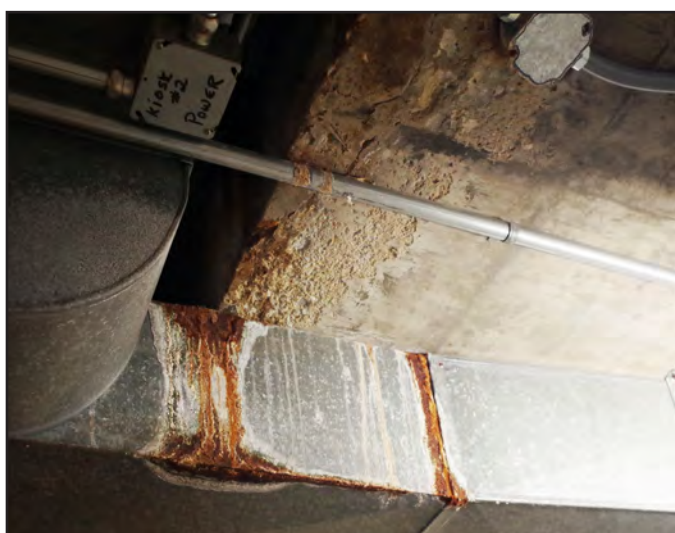
The HVAC duct work and concrete reinforcing in the basement of the former bank have rusted due to moisture infiltrating the concrete.

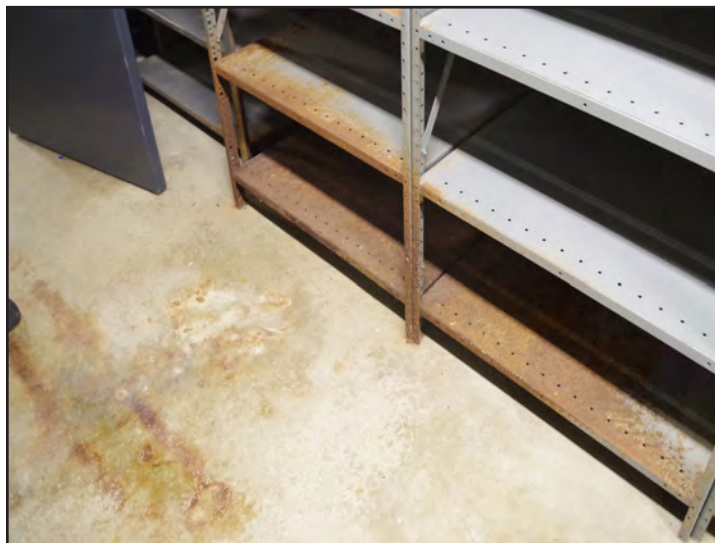
The metal shelving in the basement has rusted as a result of the moisture infiltration.

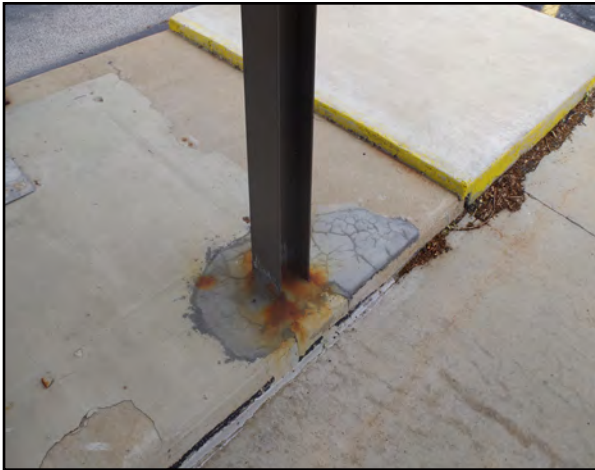
Left: The columns supporting the drive through canopy are rusted at the base.

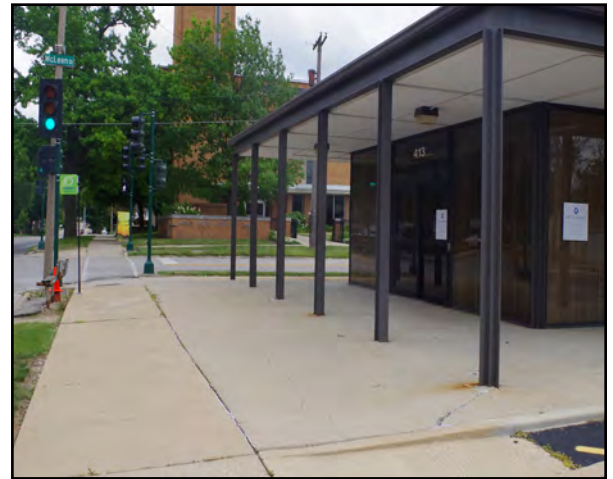
Right: The entire parcel, containing the bank building, has been paved.

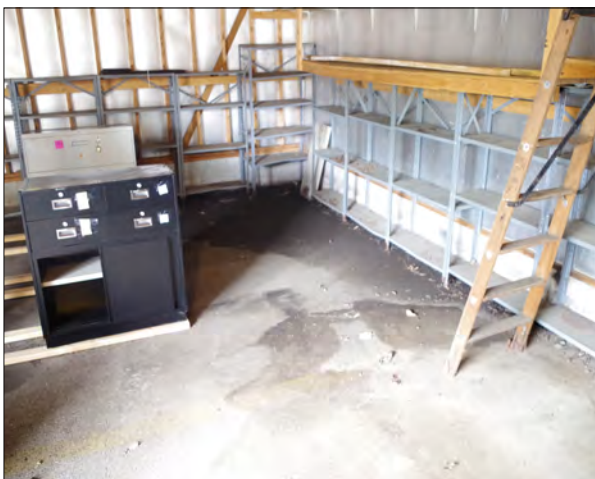
Left: Due to improper grading, water is running into the storage garage for the vacant bank.

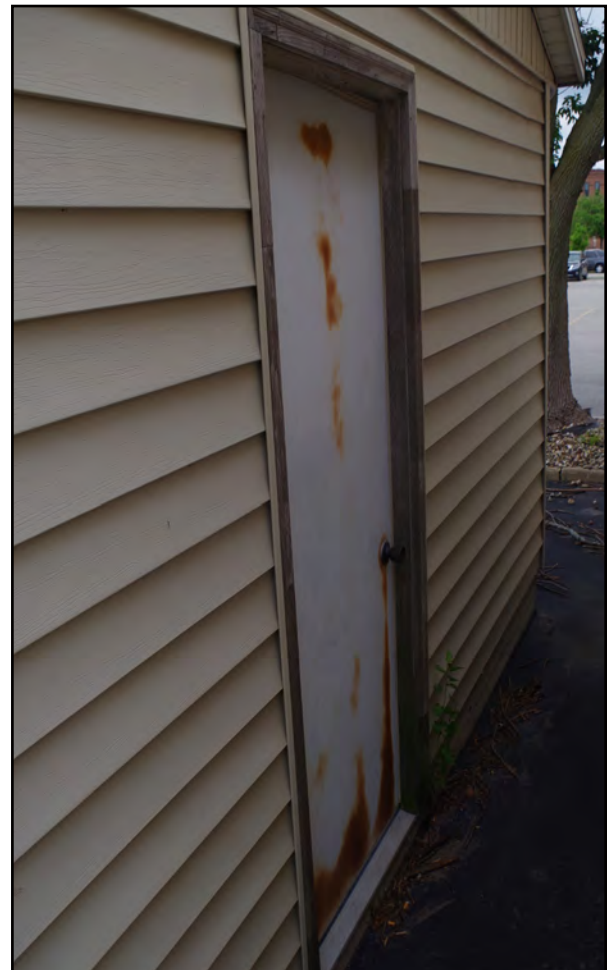
Right: The exterior door, on the garage for the vacant bank, has rusted.

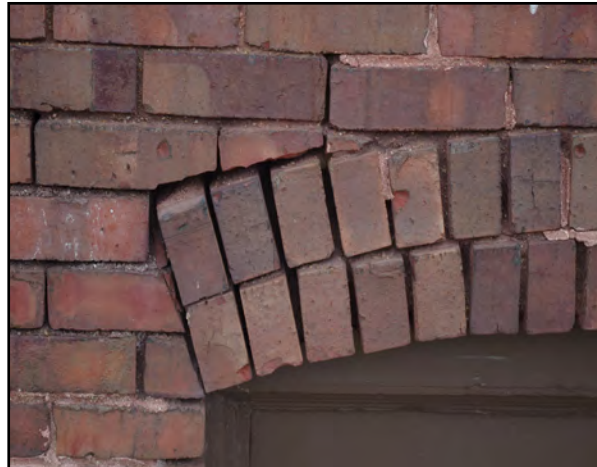
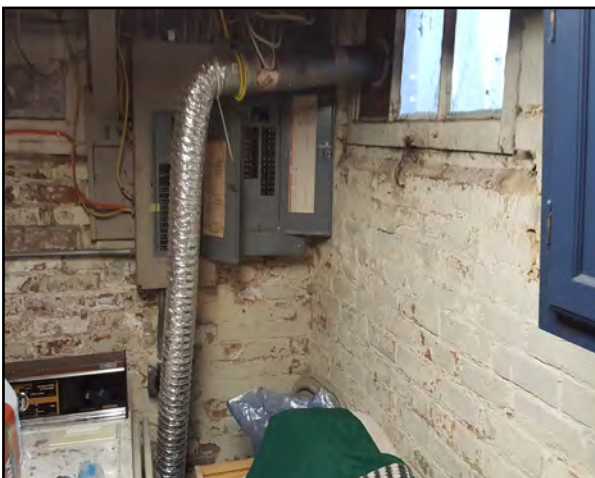
Left: Flexible
exhaust venting
ran to the window
of the salon
presents a carbon
monoxide
hazard.

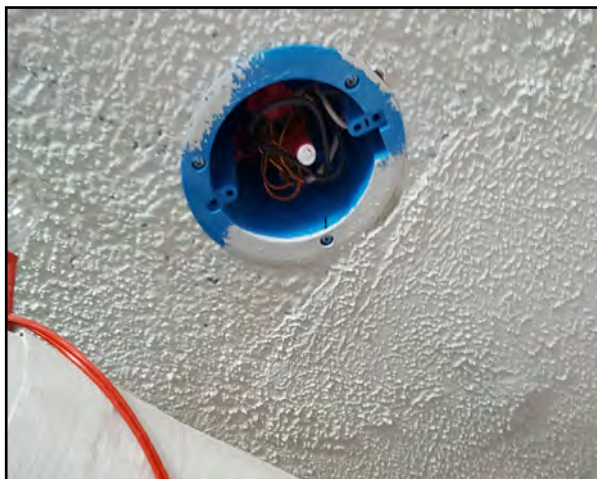
Right: A junction
box in the salon
that has not been
capped.

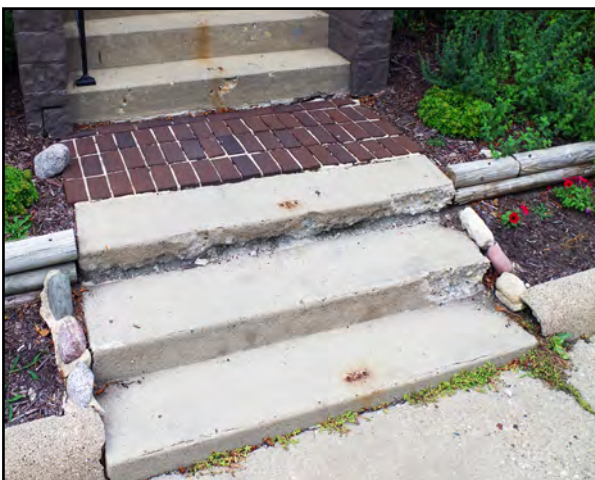
Left: The steps,
leading to the
entrance, are
deteriorated.

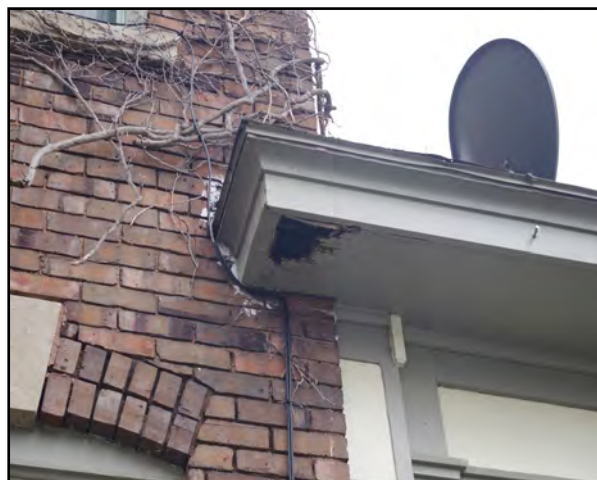
Right: Portions
of the enclosed soffit
and fascia are
rotted out.

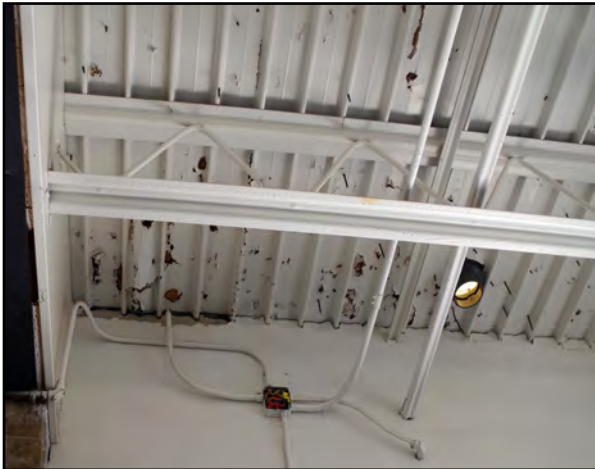
Left & Right: The old rusted roof has been covered by a new roof, which the tenants indicate leaks during strong rain, indicating improper installation.

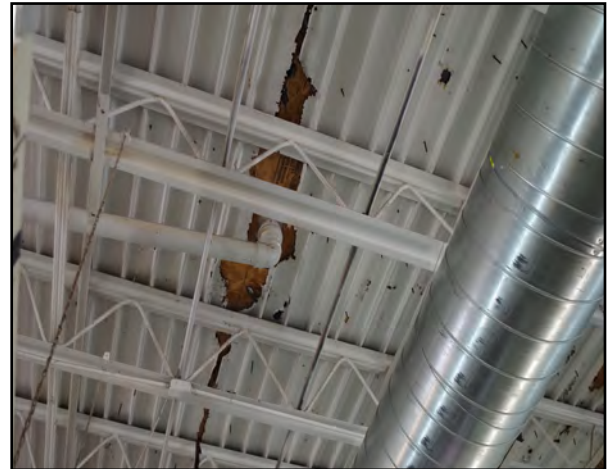
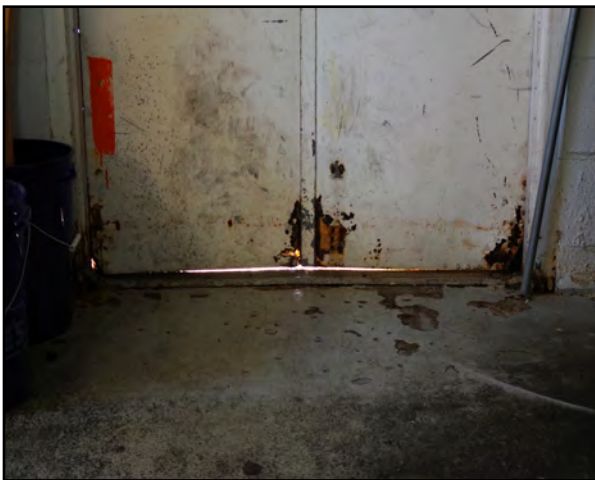
Left & Right: The rear door and door frame have corroded.

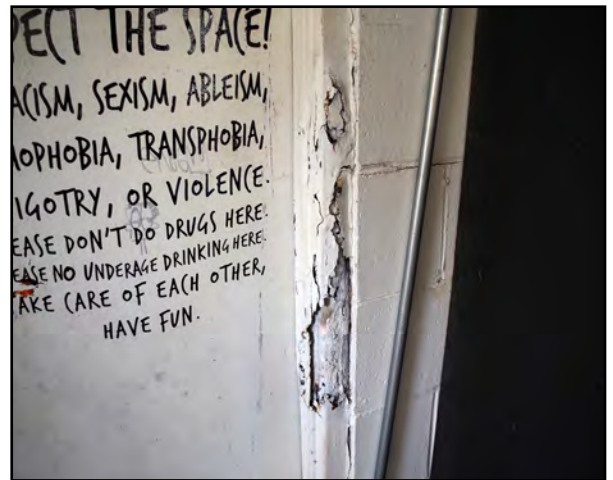
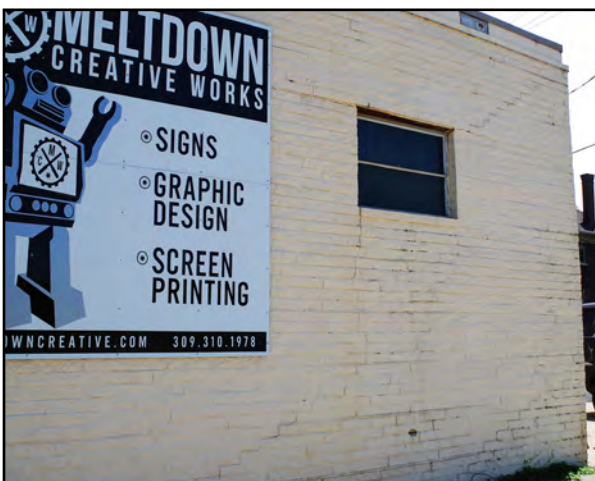
Left & Right: Step-cracking in the exterior brick walls.

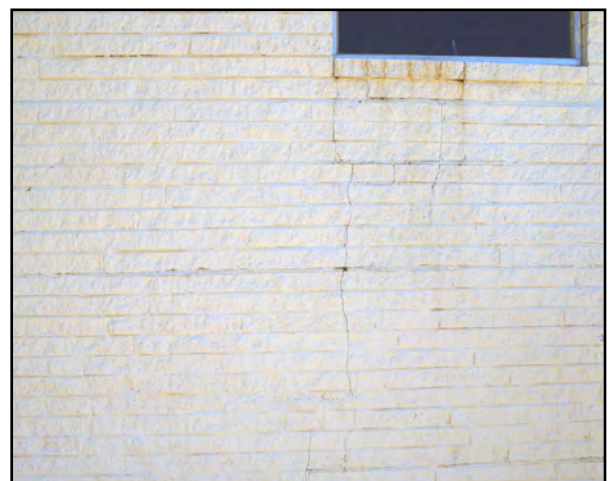
PHOTOGRAPHS OF EXISTING CONDITIONS

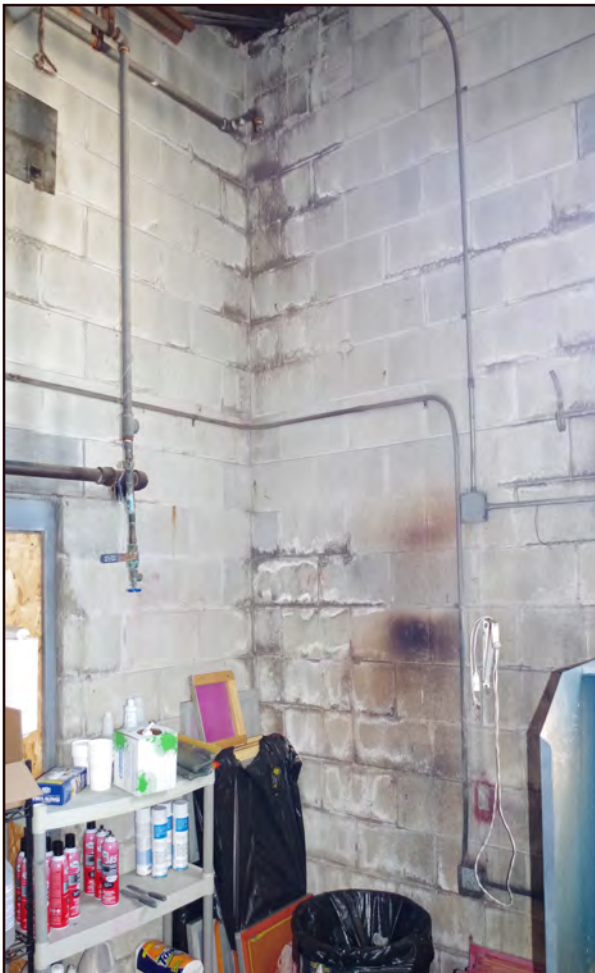
Left: Moisture penetrating through the CMU wall into the interior of the building.

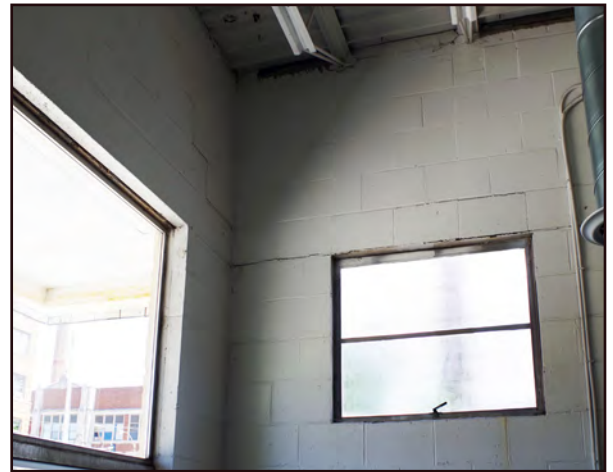
Right: Step cracking in the interior CMU walls.

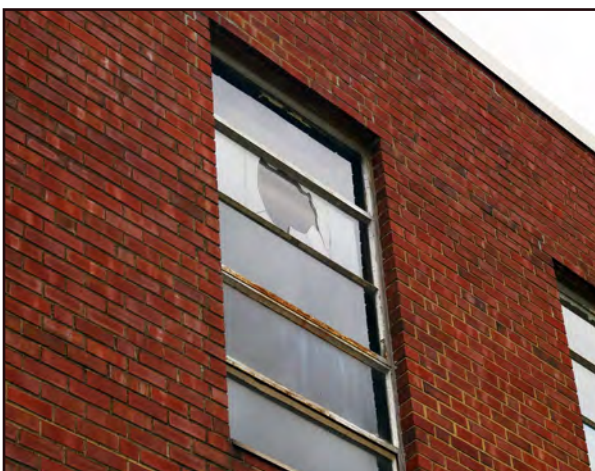
Left: A broken exterior window at the church. Note rusted window muntin.

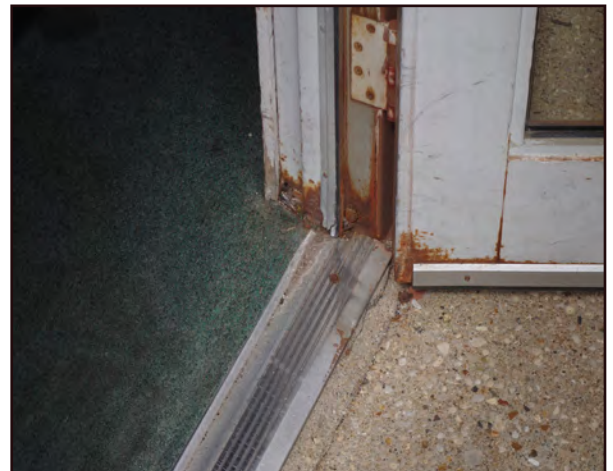
Right: A rusted door frame located at a church entrance.

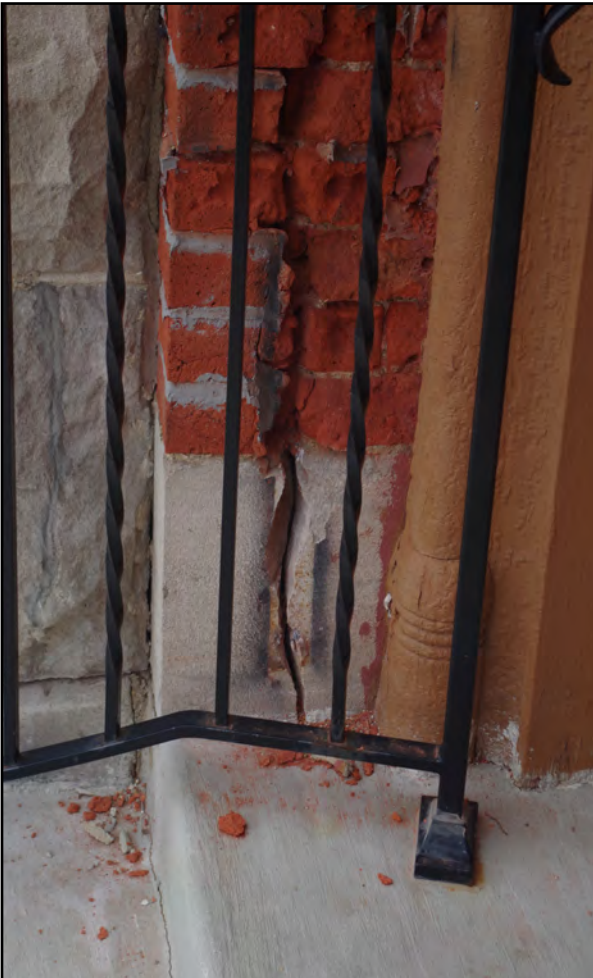
Left: Disintegrating exterior brick wall of the church.

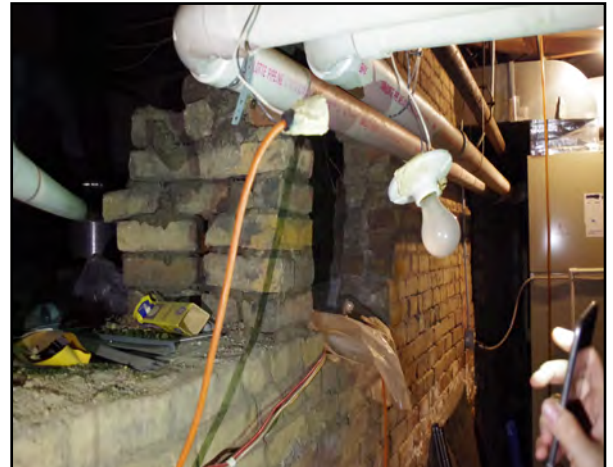
Right: A basement light improperly wired into an extension cord.

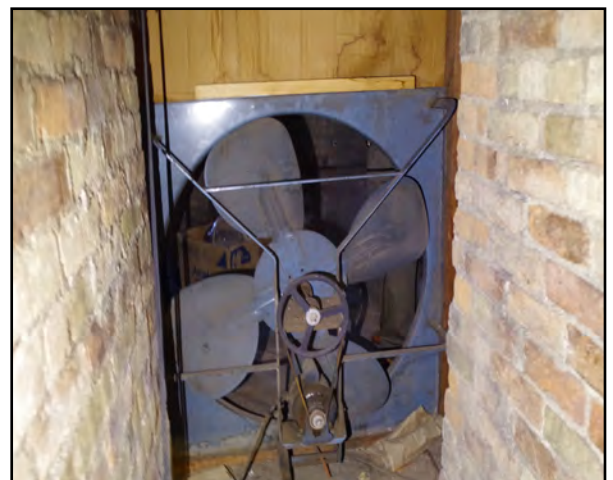
Right: A vent fan in the bell tower adjacent to the balcony lacks a safety screen.

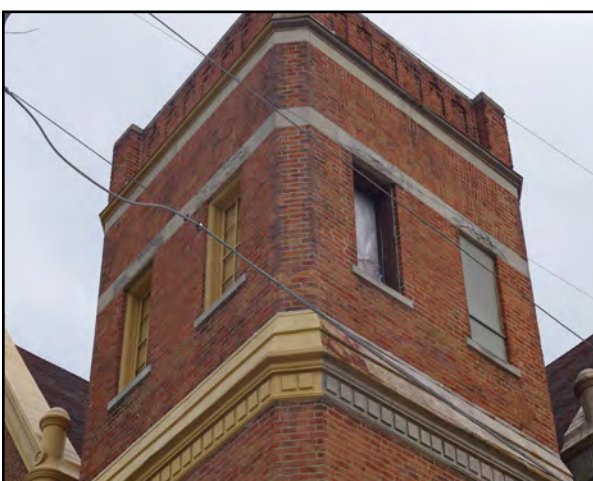
Left: A missing window in the church tower allows the weather and wildlife to enter into the structure.

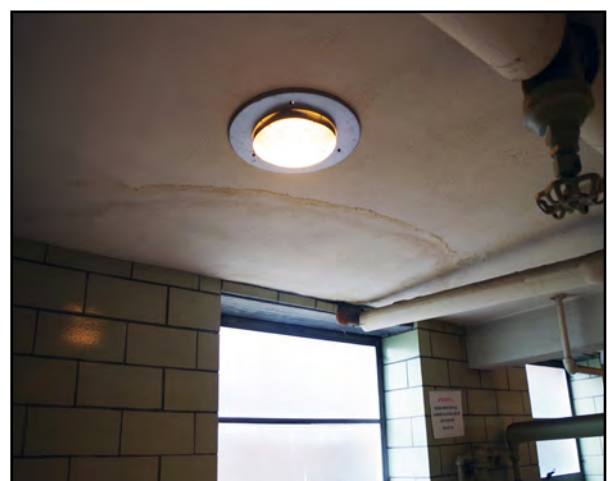
Right: Water damage to the ceiling in the church's basement kitchen.

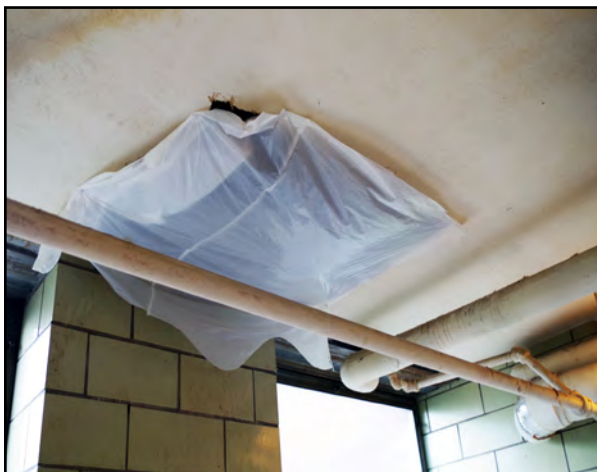
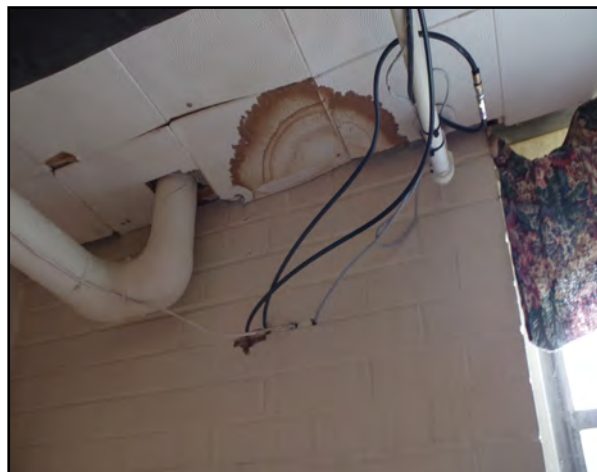
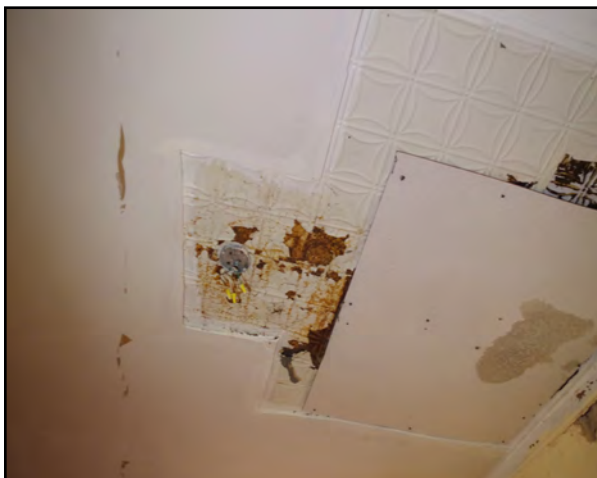
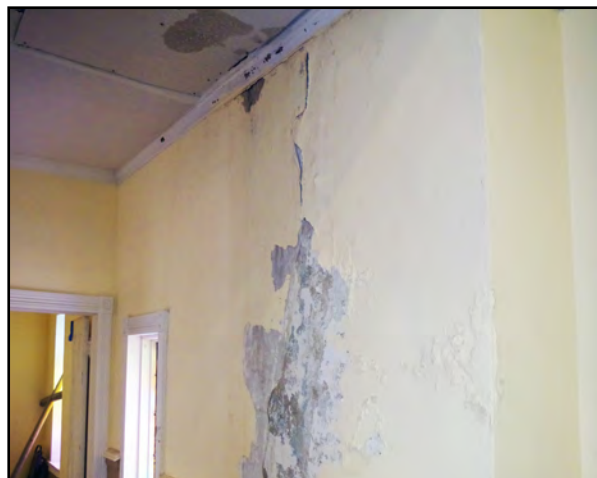
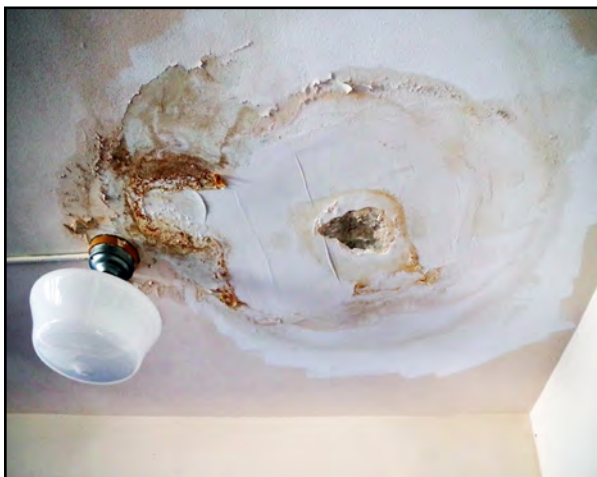
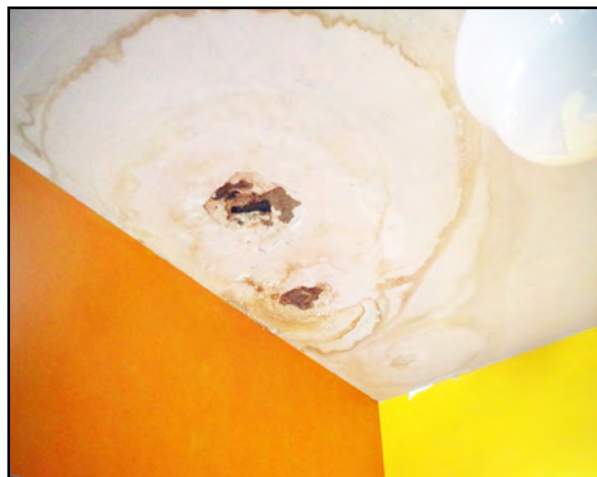
PHOTOGRAPHS OF EXISTING CONDITIONS

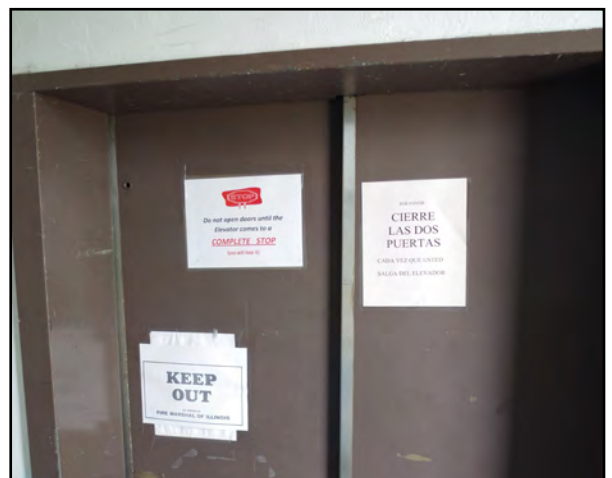
510 East Washington Street (Former School) (cont'd)

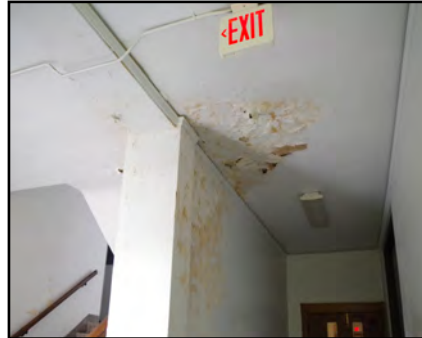
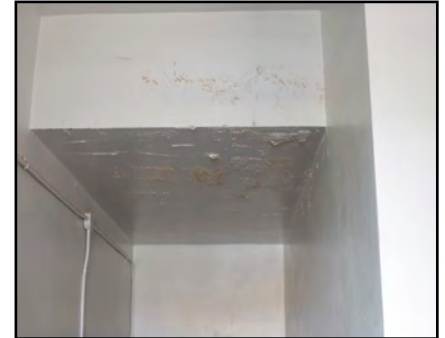
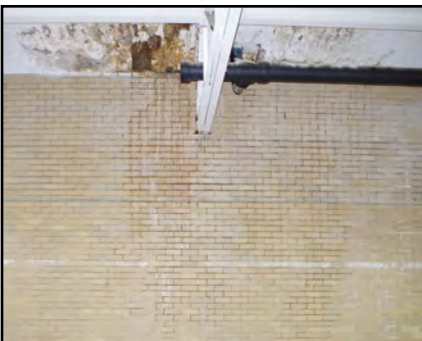
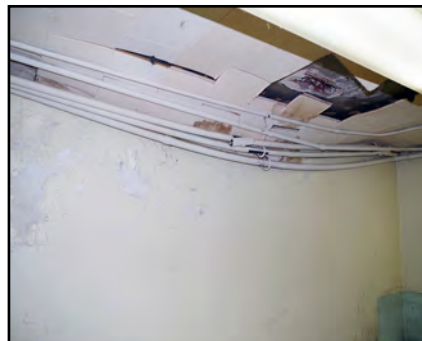
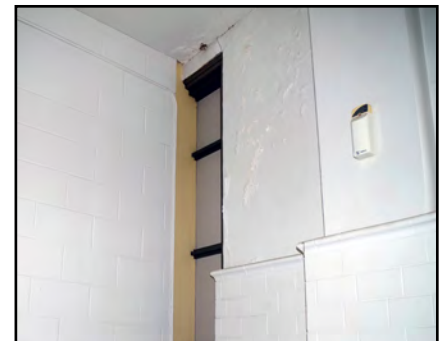
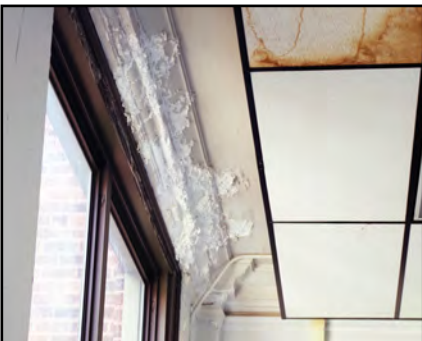
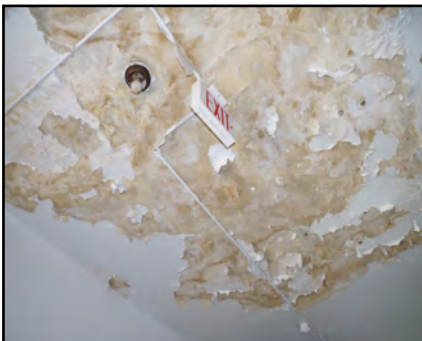
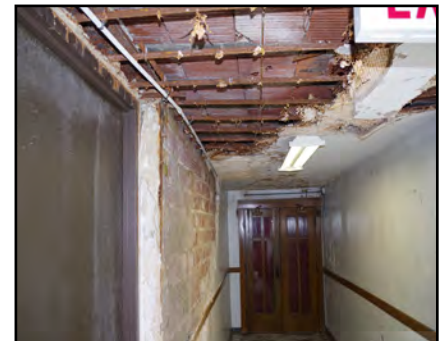
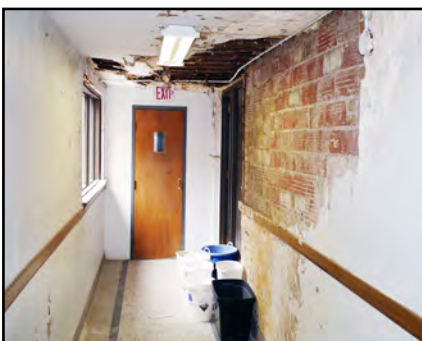
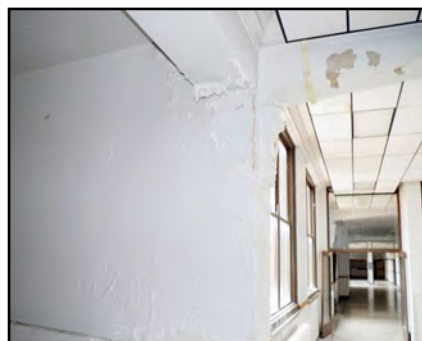
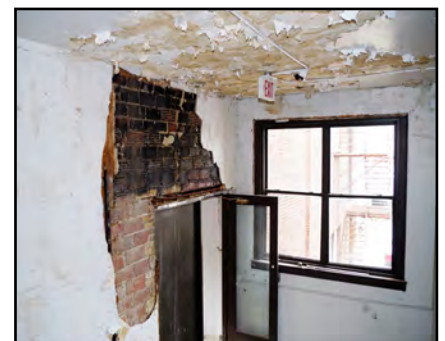
510 East Washington Street (Former School) (cont'd)

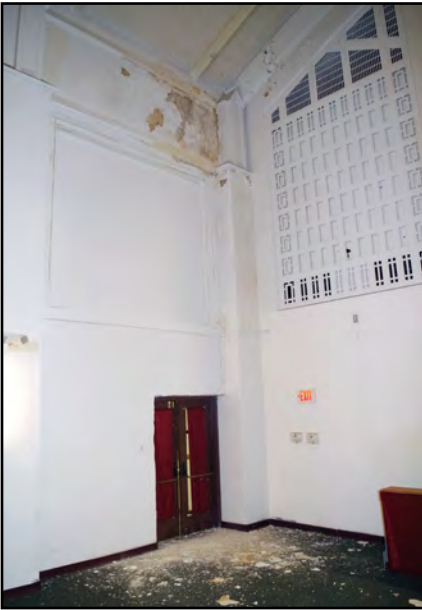
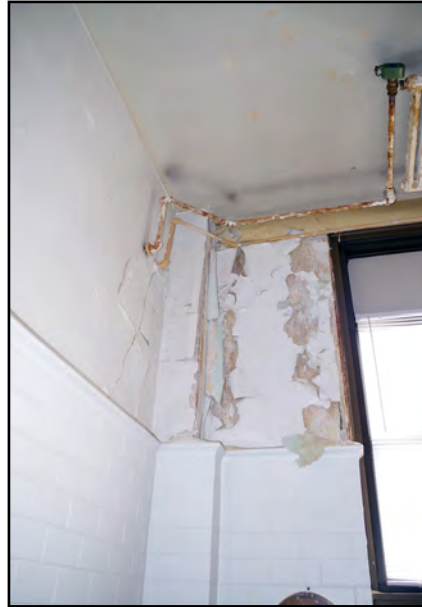
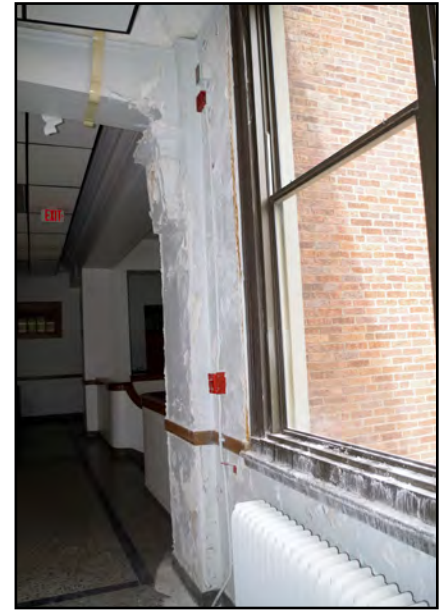
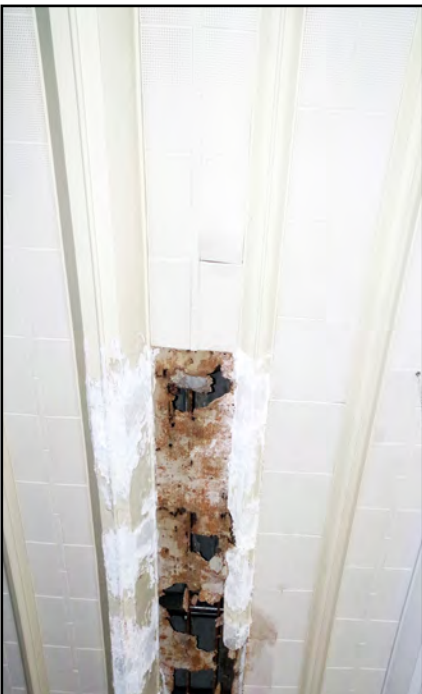
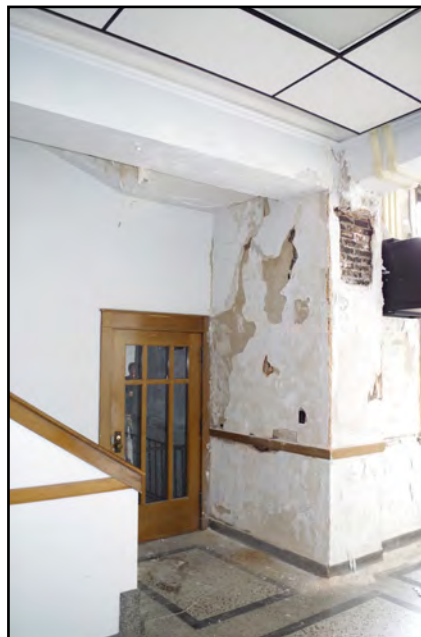
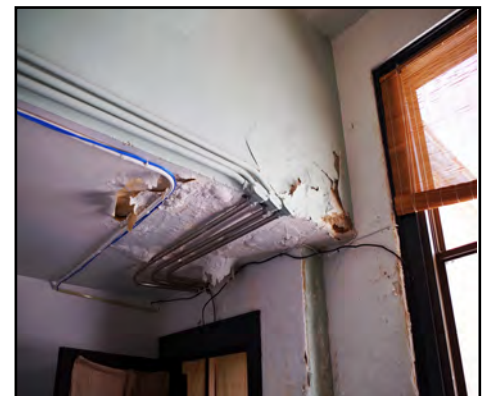
PHOTOGRAPHS OF EXISTING CONDITIONS

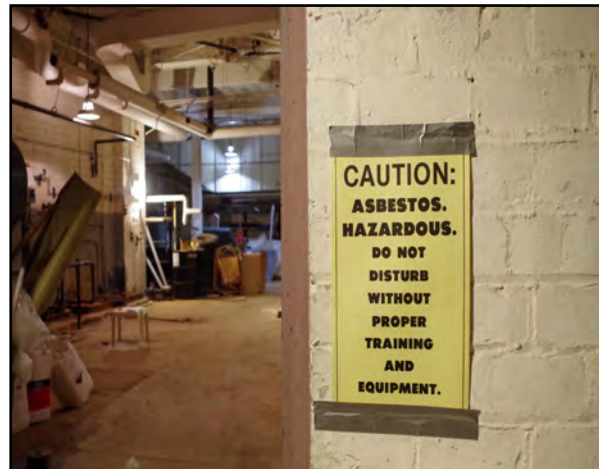
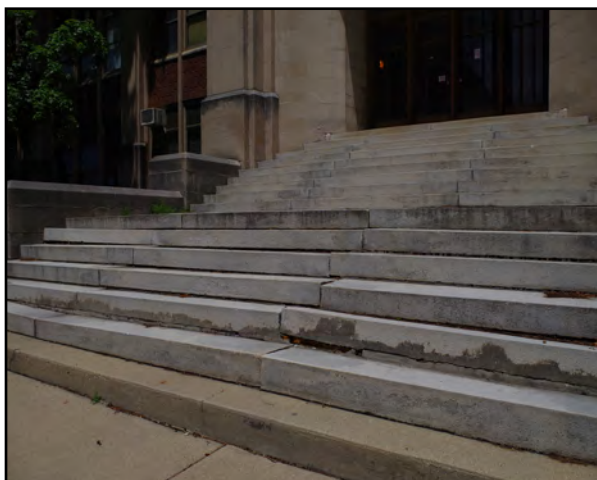
Left: The front entry steps to the former school are deteriorated and not level.

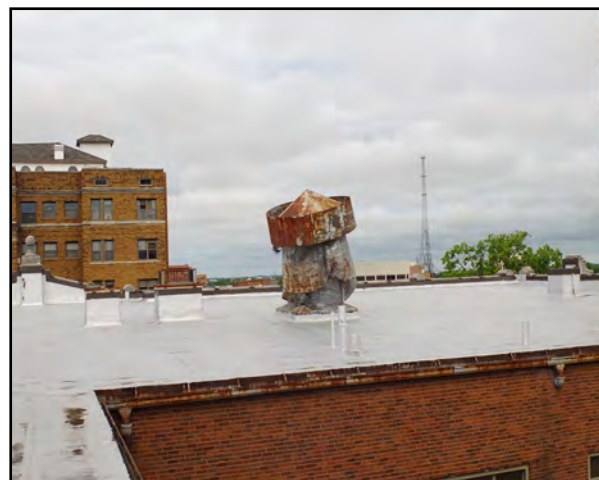
Right: The exhaust hood on the top of the former school is leaning.

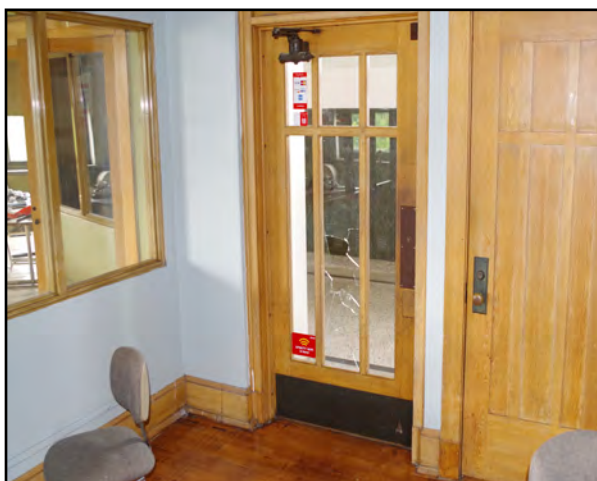
Left: Broken glass in one of the rooms on the third floor of the school building.

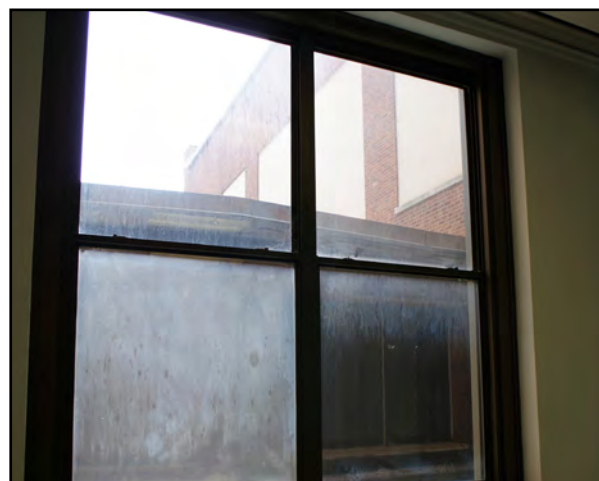
Right: The window seals on several of the windows have failed.

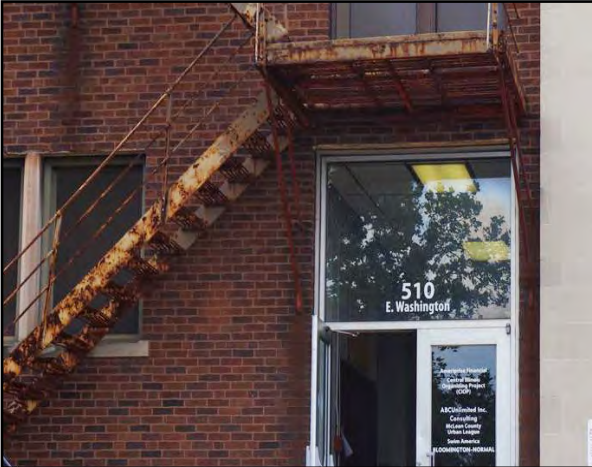
Left: A rear fire escape that has rusted and become deteriorated.

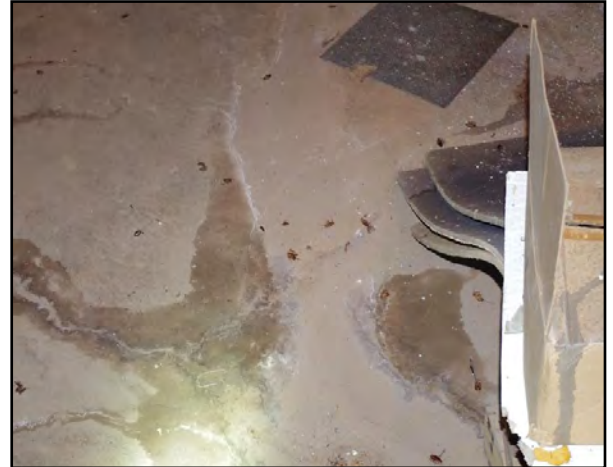
Right: The basement of the former school contains hundreds of dead cockroaches.

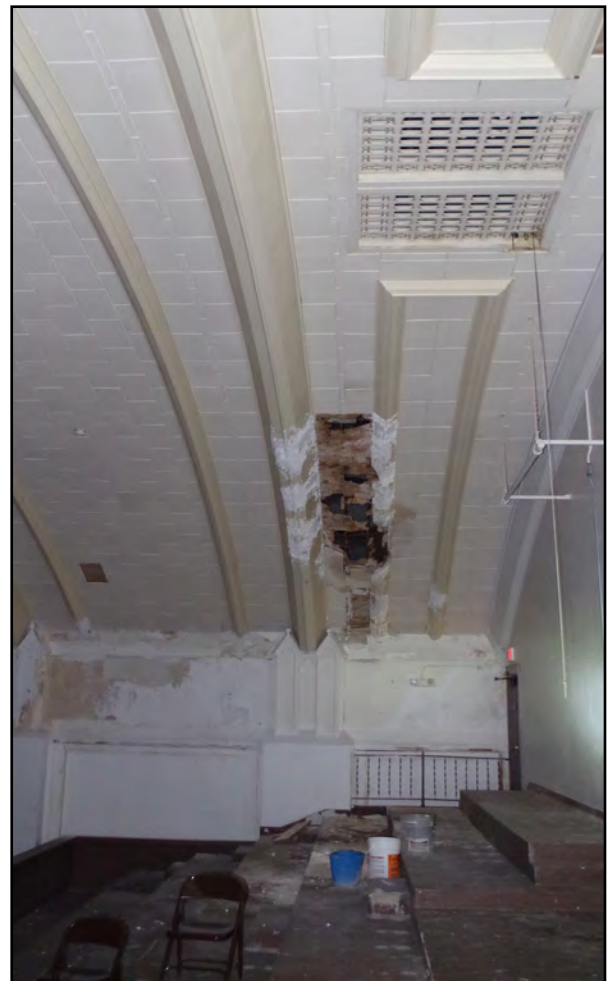
Right: Damage to the balcony ceiling, in the auditorium, of the former school.

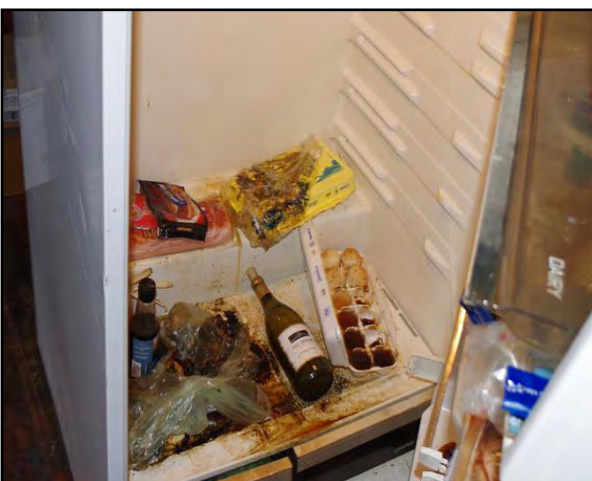
Left: Abandoned refrigerator with spoiled food.
