Tax Increment Financing Redevelopment Plan

.....
Downtown East Washington Street
Redevelopment Project Area
.....

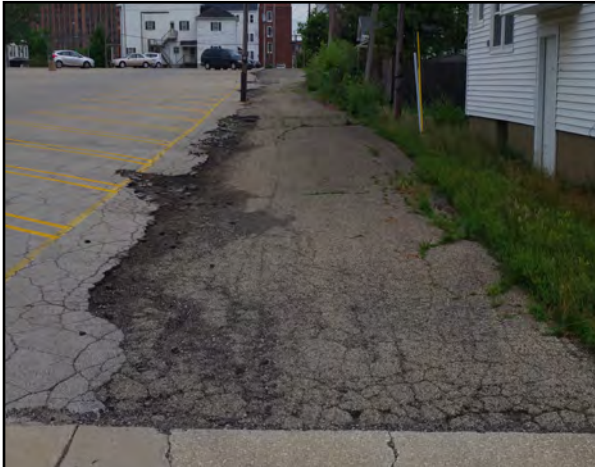
Left & Right: The edge of the pavement at 402 East Jefferson Street is crumbling and deteriorated.

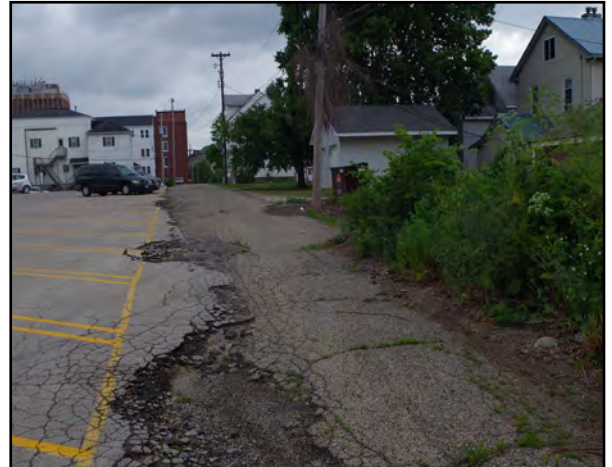
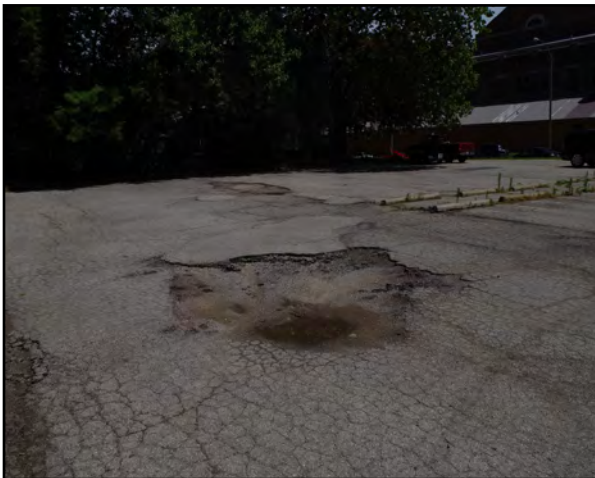
Left: The parking lot at 500 East Jefferson is deteriorated and contains large potholes.

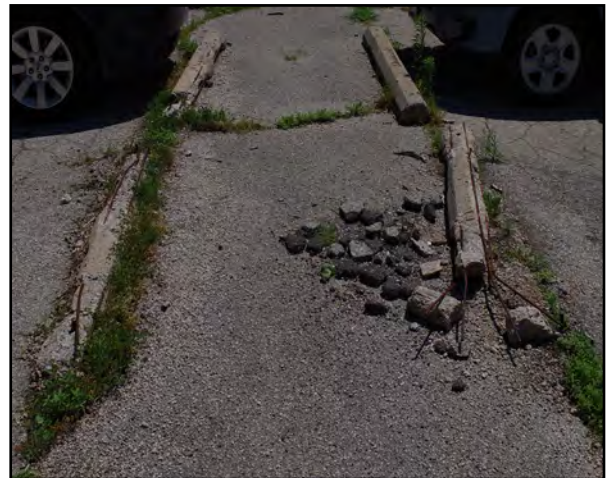
Right: The parking stops at 500 East Jefferson are crumbling and deteriorated.

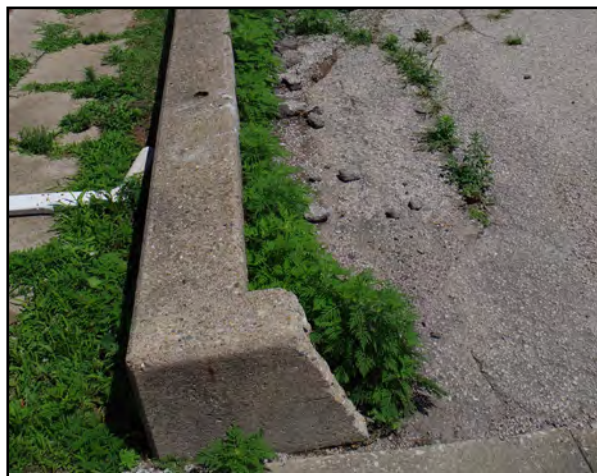
Left: The retaining wall on the north side of 500 East Jefferson is leaning.

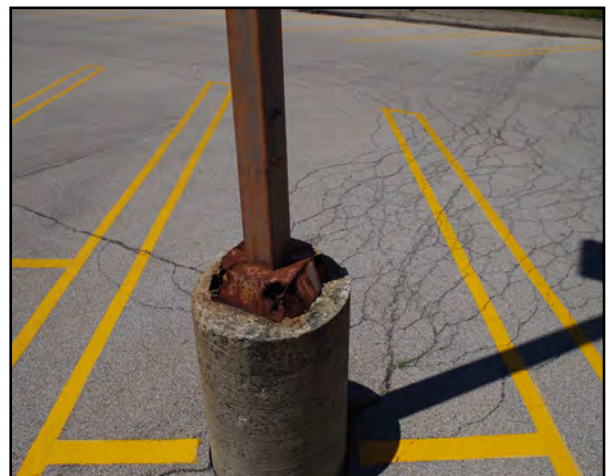
Right: Several of the light standards at 402 East Jefferson are deteriorated.

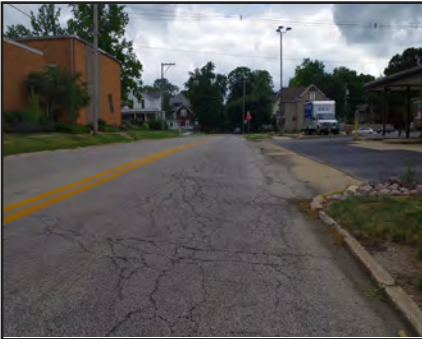
Above: The pavement along North McLean Street is deteriorated.

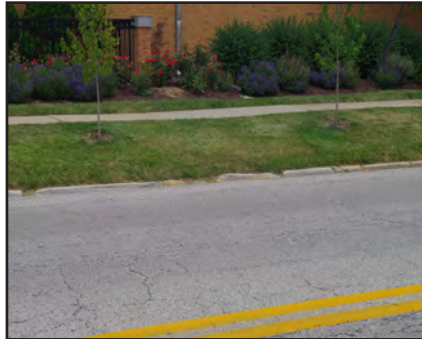
Above: The curbs along North McLean Street are deteriorated.

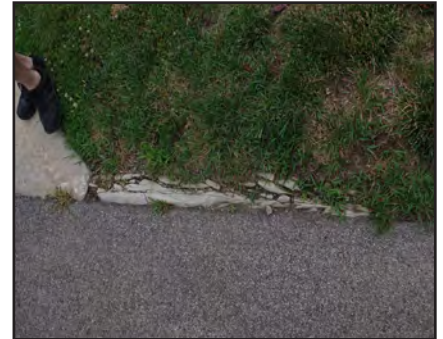
Above: The curbs along East Front Street are deteriorated.

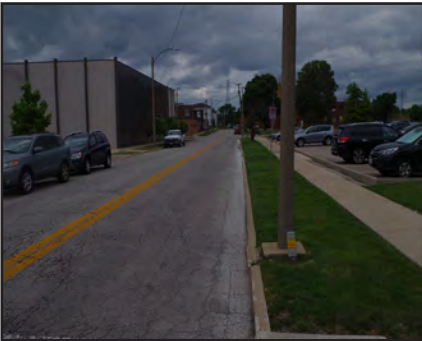
Below: The pavement and curbs are deteriorated at the intersection of Gridley and Jefferson.

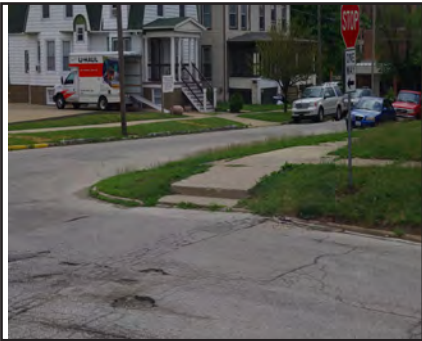
Below: Deteriorated pavement along North McLean Street.

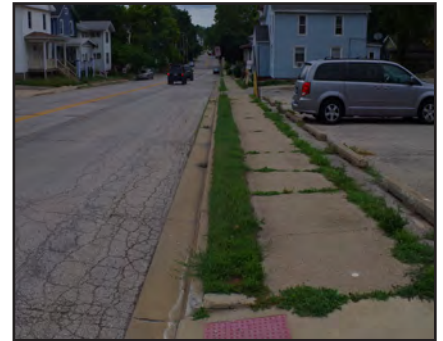
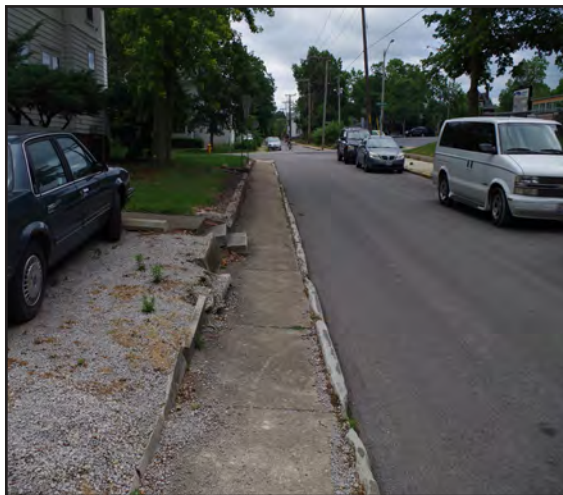
Left: Deteriorated curbs along North McLean Street.

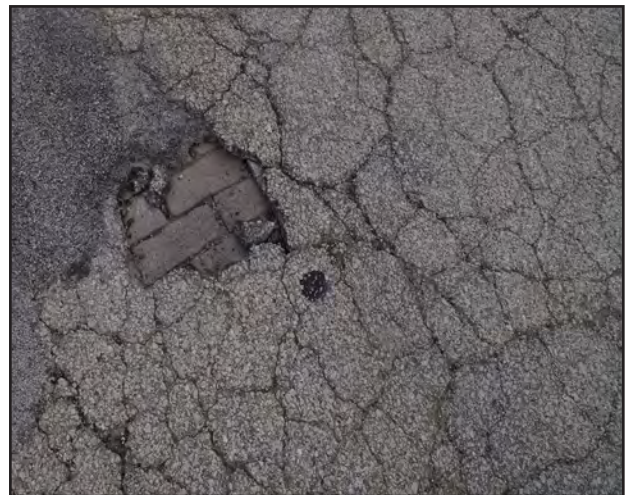
This Page Intentionally Blank
