# **Tax Increment Financing Eligibility Study**

.....  
North Main Street /Chestnut Street  
Redevelopment Project Area  
.....

**City of Bloomington, Illinois**

**PGAV PLANNERS**

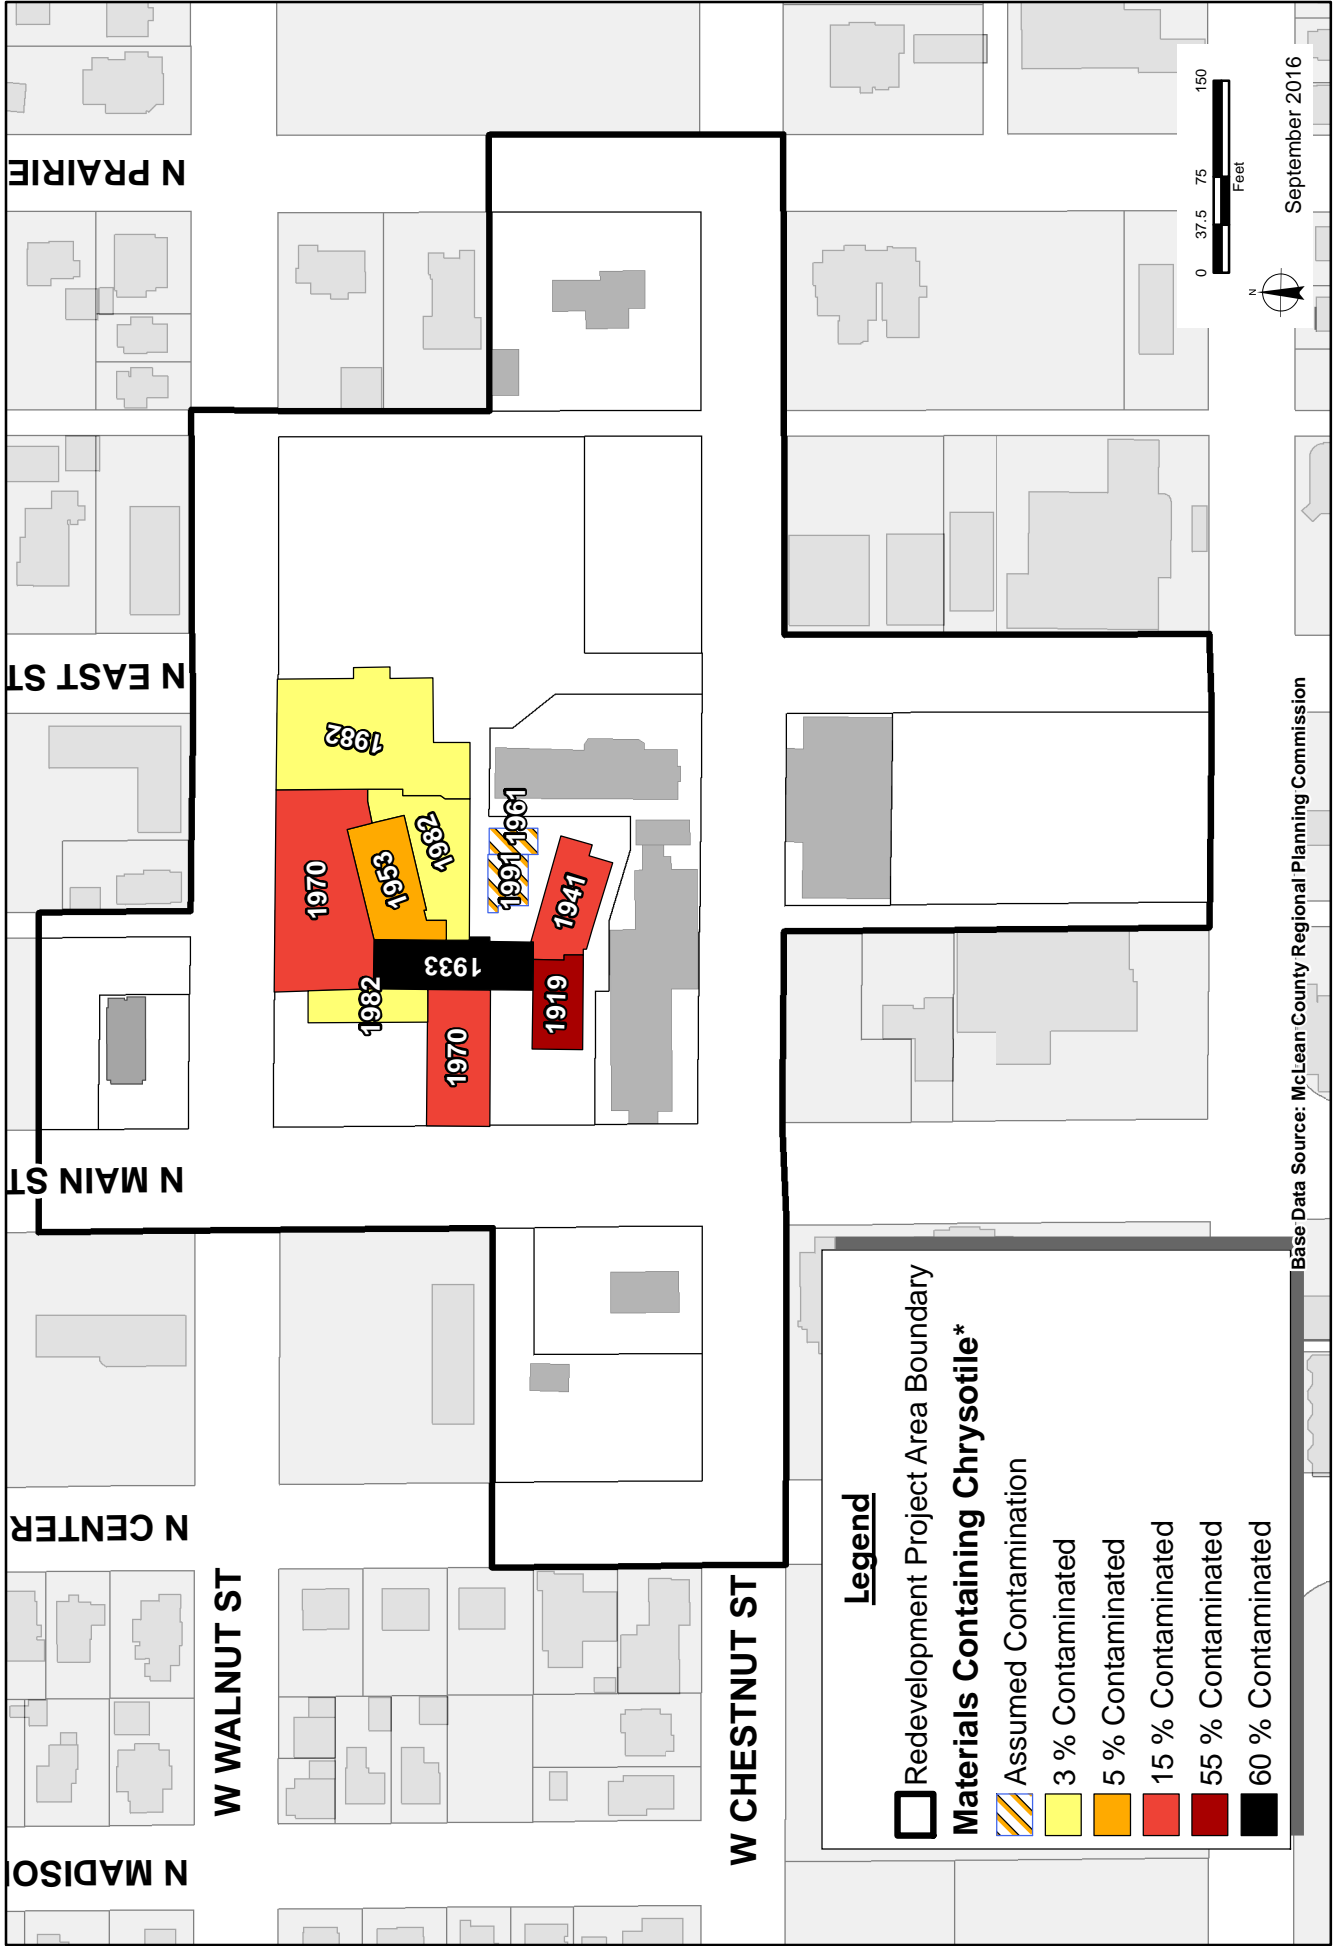
### Exhibit H - Former Electroflux Facility Asbestos Contamination

**Exhibit H - Former Electrolux Facility Asbestos Contamination** shows the level of contamination throughout the former Electrolux facility before demolition began. **Attachment D - Limited Asbestos-Containing Building Materials Inspection**, found in the Appendix, contains a detailed report of the contamination found on site. Before the former Electrolux facility was demolished, a Limited Asbestos-Containing Building Material Inspection was performed in March 2011 by McKee Environmental, Inc. at the request of Kirk Holdings, LLC. All of the buildings in the complex were either assumed to contain asbestos or found to contain asbestos in an amount at or above the level deemed dangerous by the U.S. Environmental Protection Agency. Kirk Holdings, LLC, the owner of the subject property and the company performing the demolition of the Electrolux site, was issued a building permit with a stated cost of \$28,000 to perform the asbestos removal.

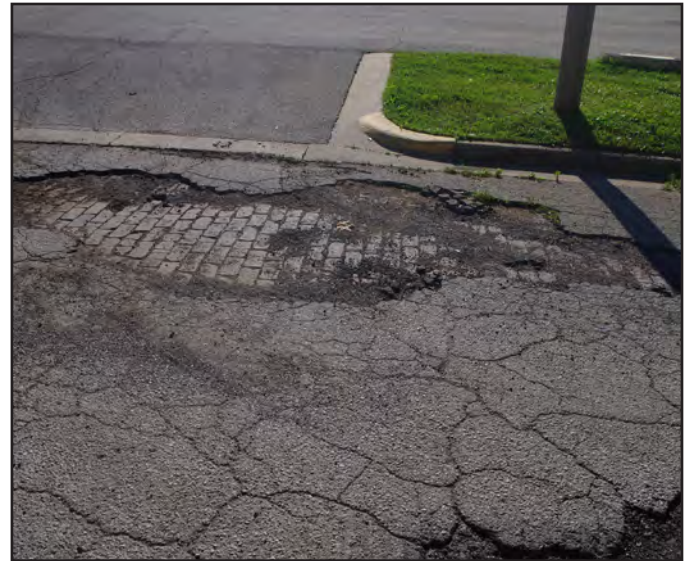
The asphalt pavement on North East Street, located on the 804 North East Street property, has disintegrated exposing the old brick street surface.

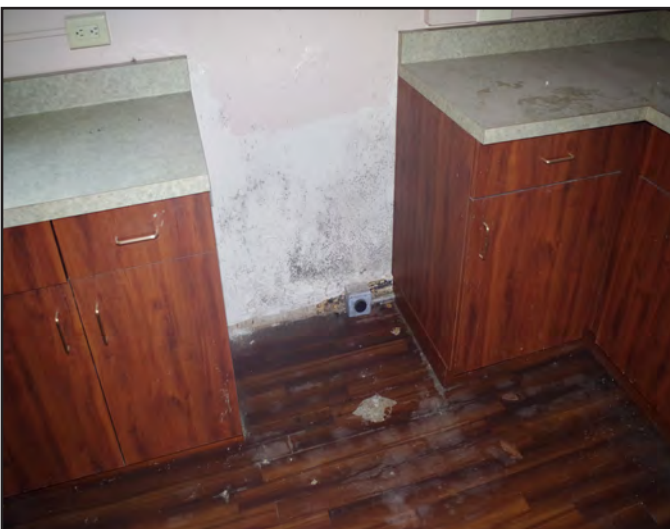
Mold growing on the wall inside of the former dormitory.

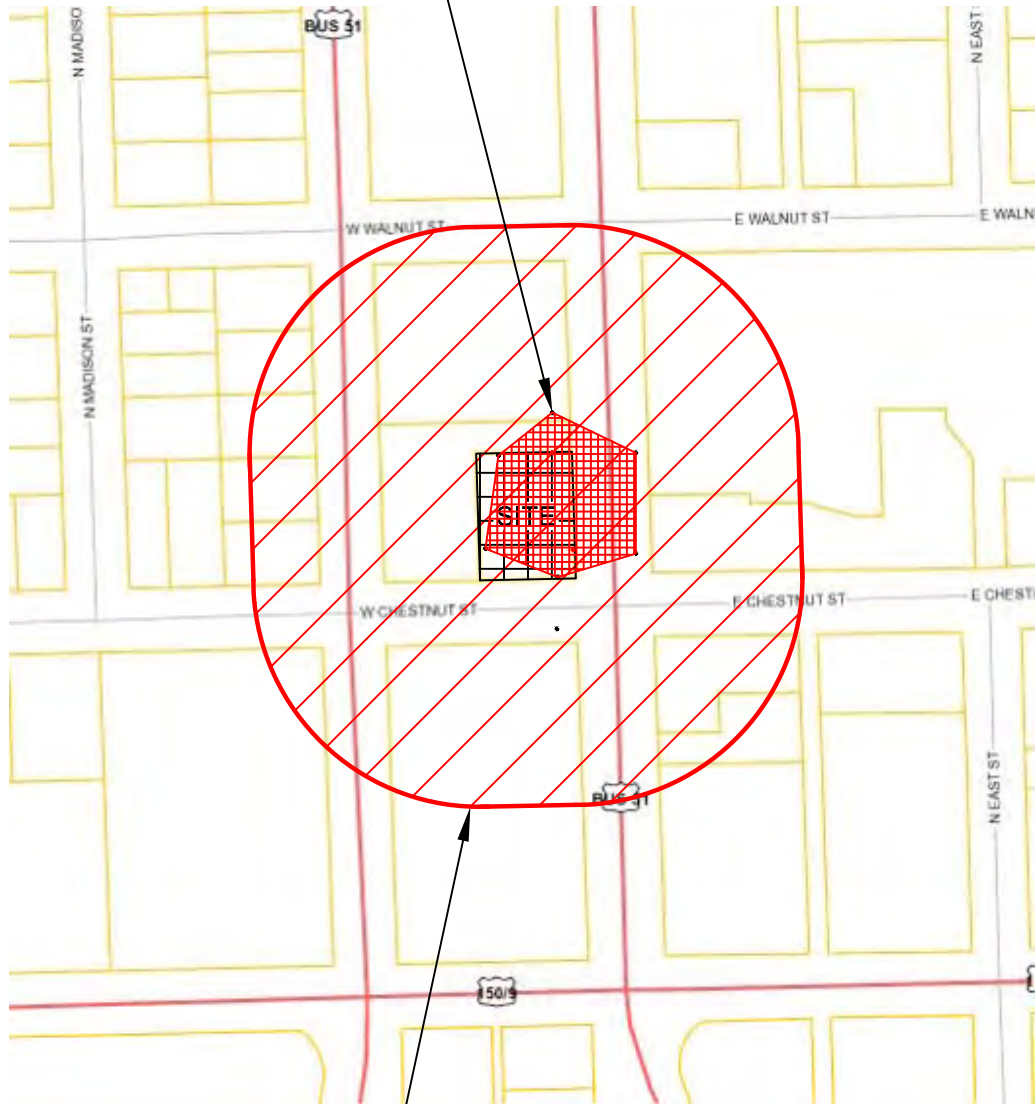
Extent of groundwater impact in excess of Tier 1 residential groundwater remediation objectives

Modeled groundwater impact radial distance of 236 feet using RBCA Equation R26 and area of environmental notice letter submittals
